LEVEL THREE

# Your survey report

██████ Luke Street, London, London, United  
Kingdom, EC2A ██████

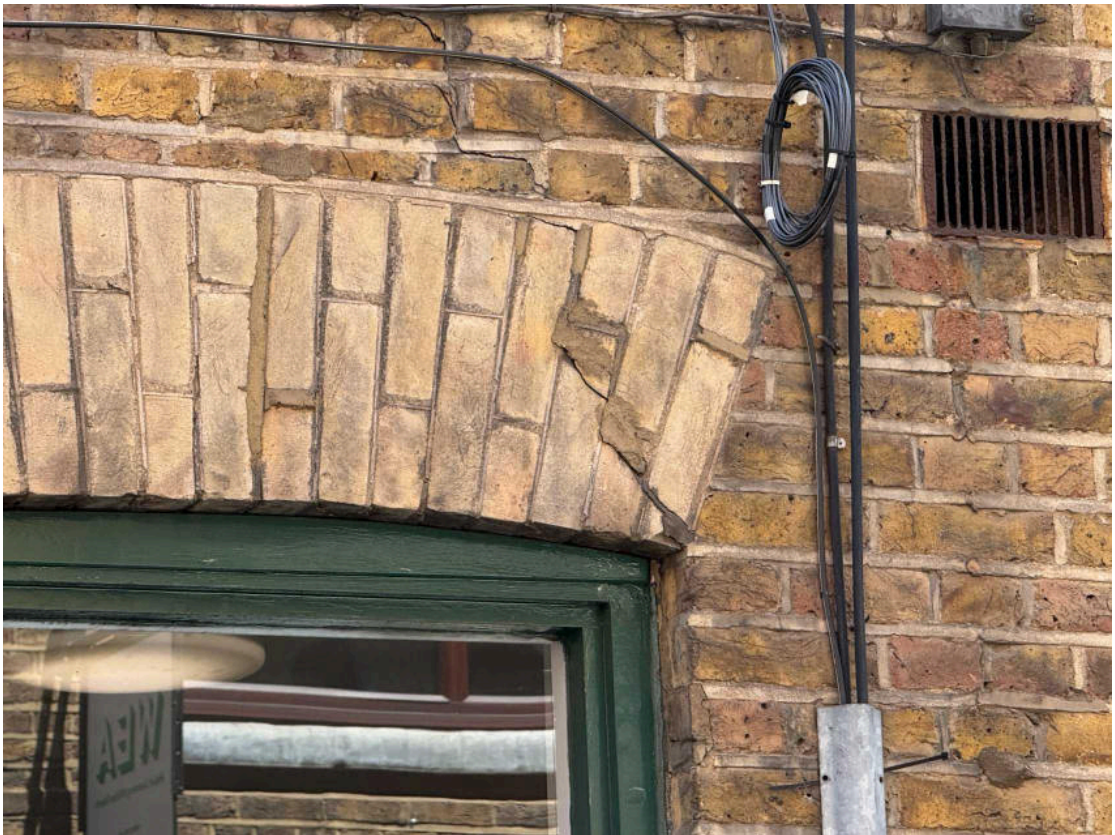
Many surrounding buildings, including the main building housing the subject unit, have suffered some form of movement, with cracks noted at all elevations. You should enquire whether this building is subject to any claims previously or outstanding.

***Crack on the comunal door brick arch lintel***

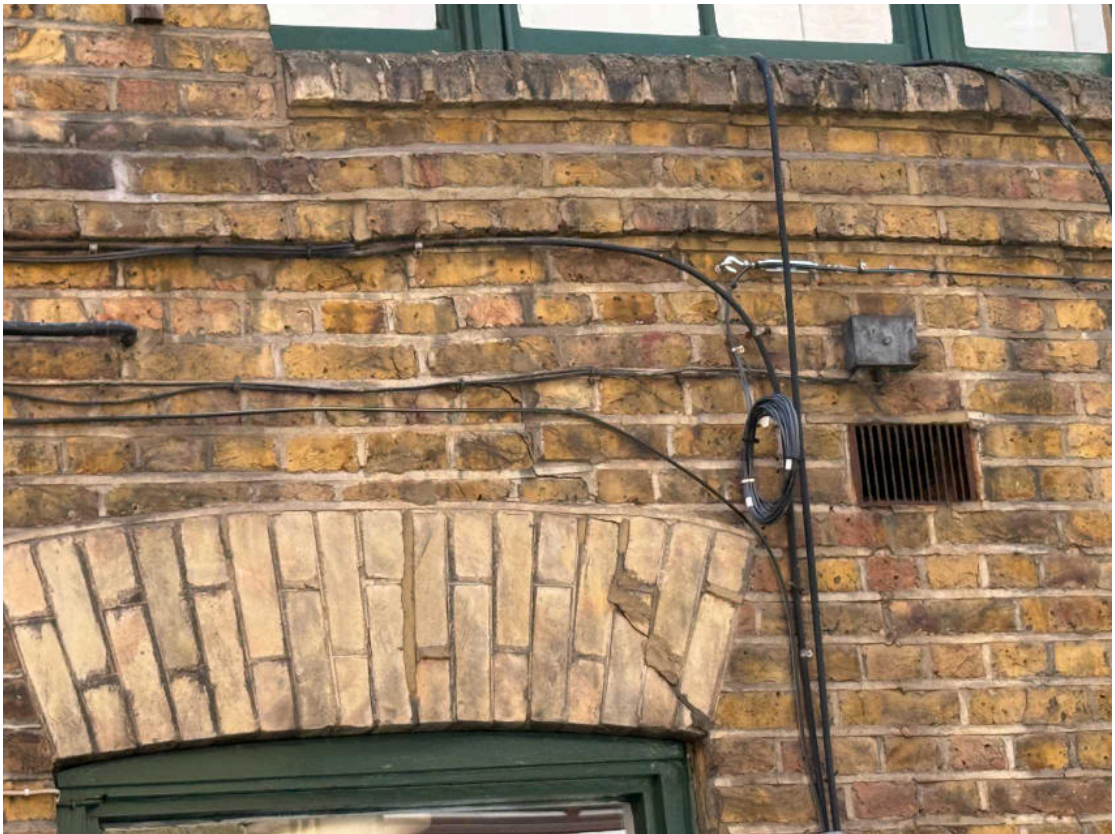
***Crack on the comunal door brick arch lintel***

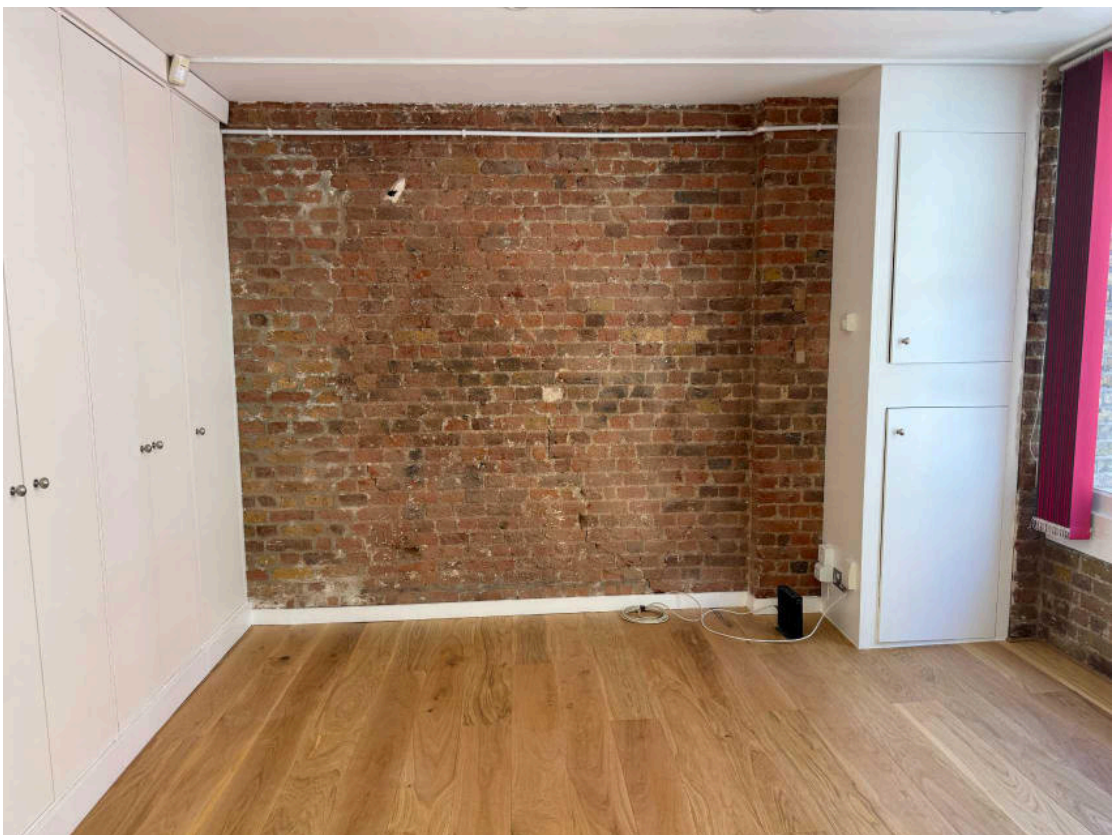
***Crack on the bric faced wall***

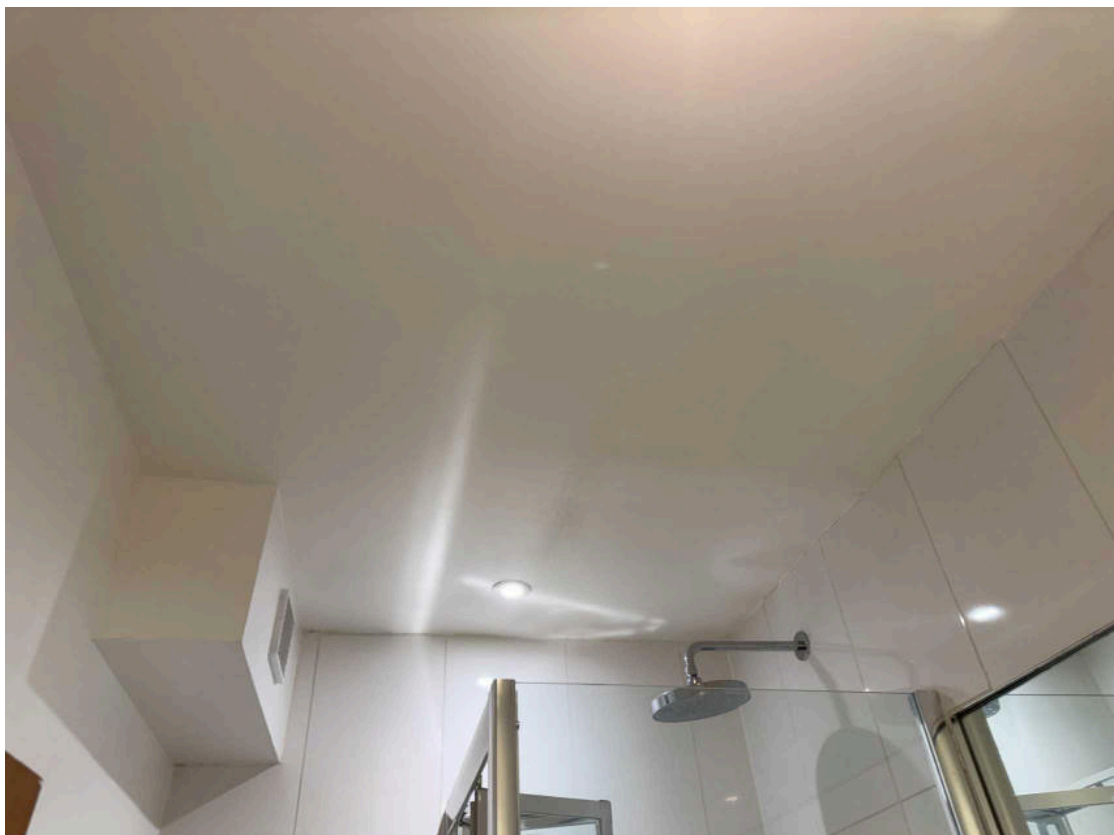
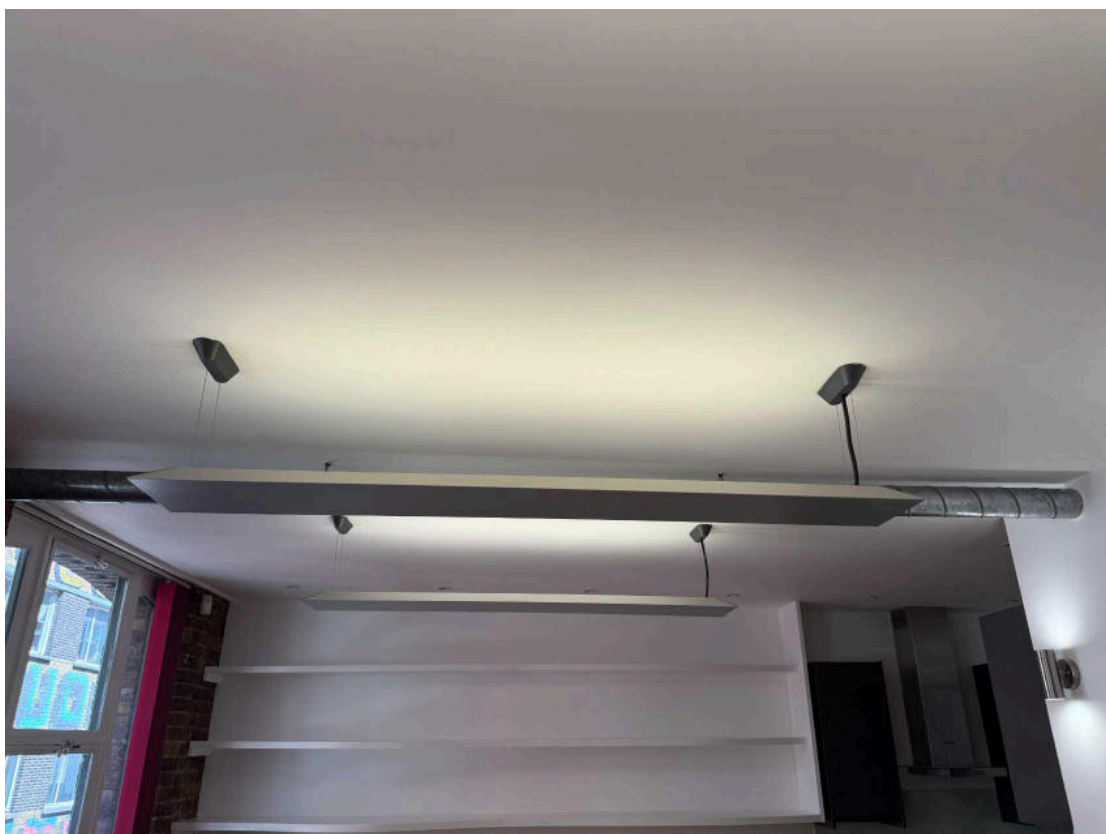
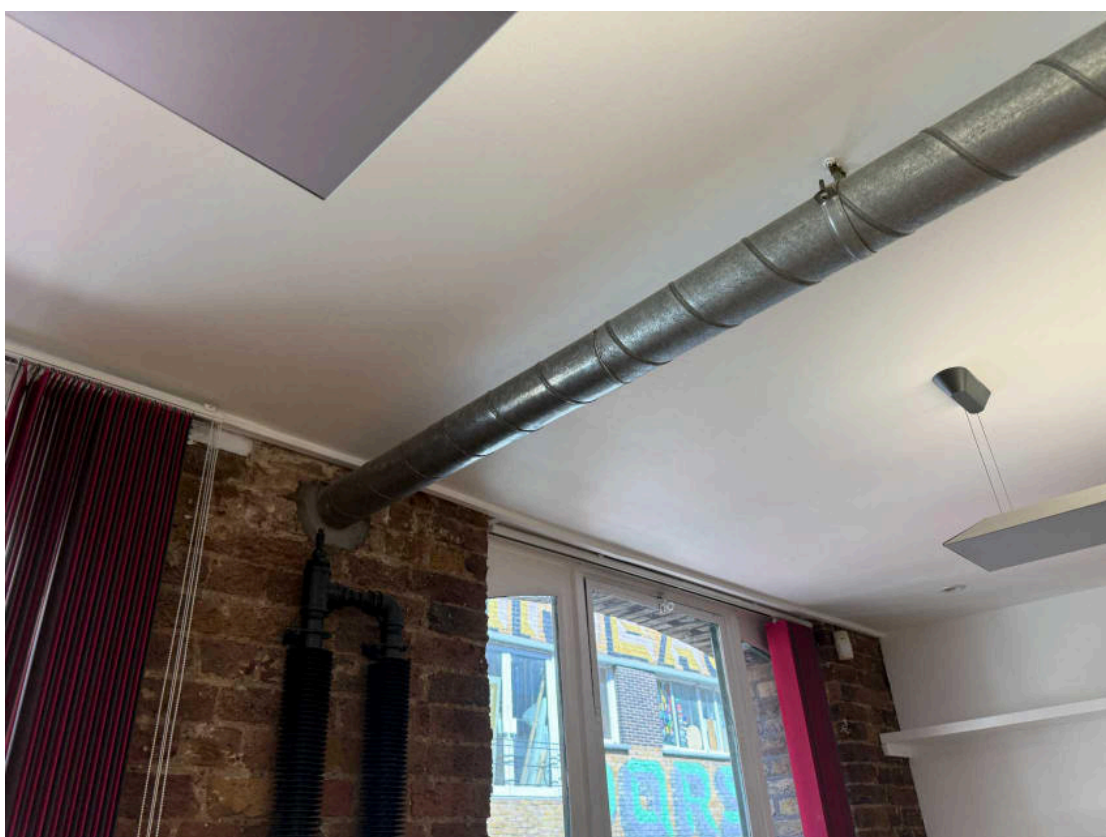
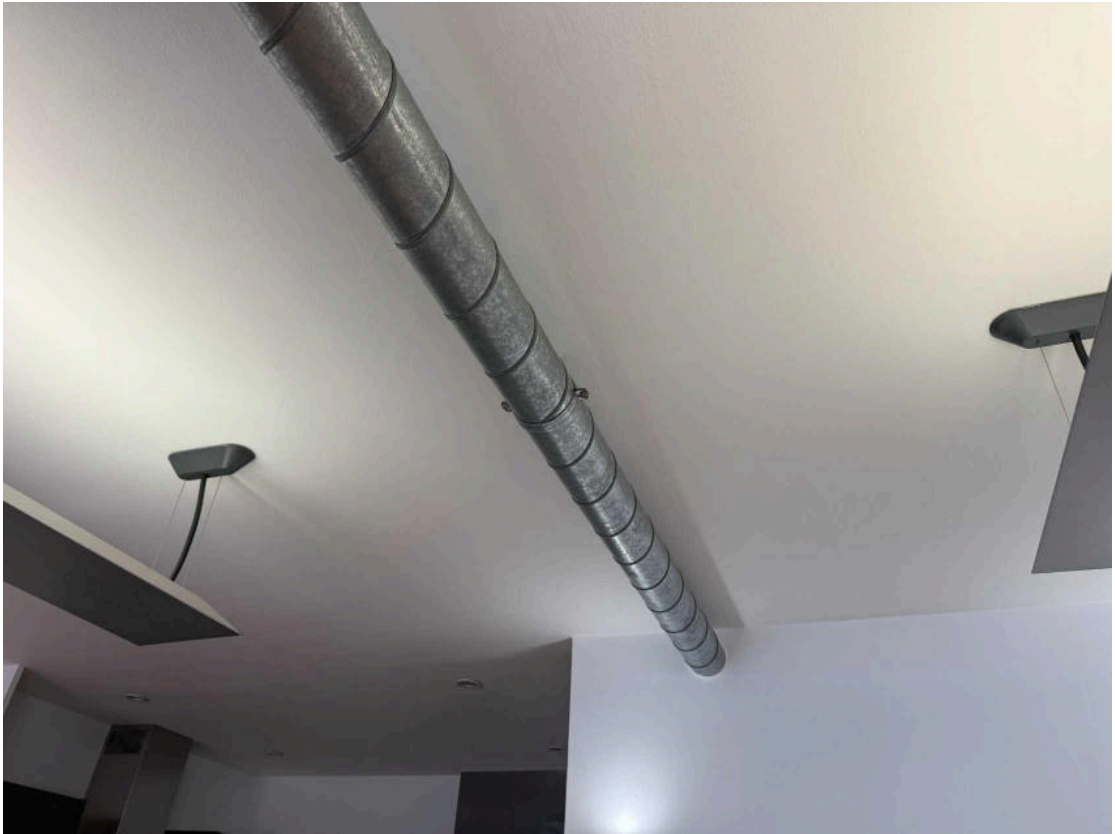
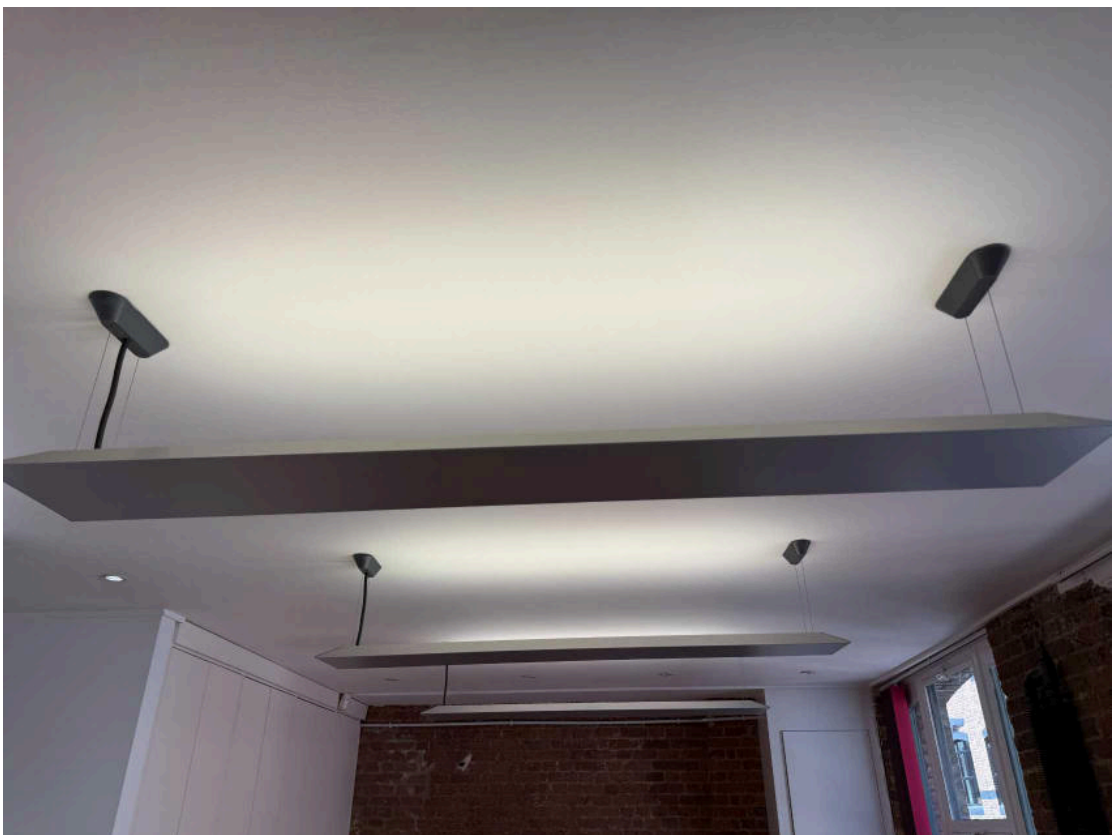
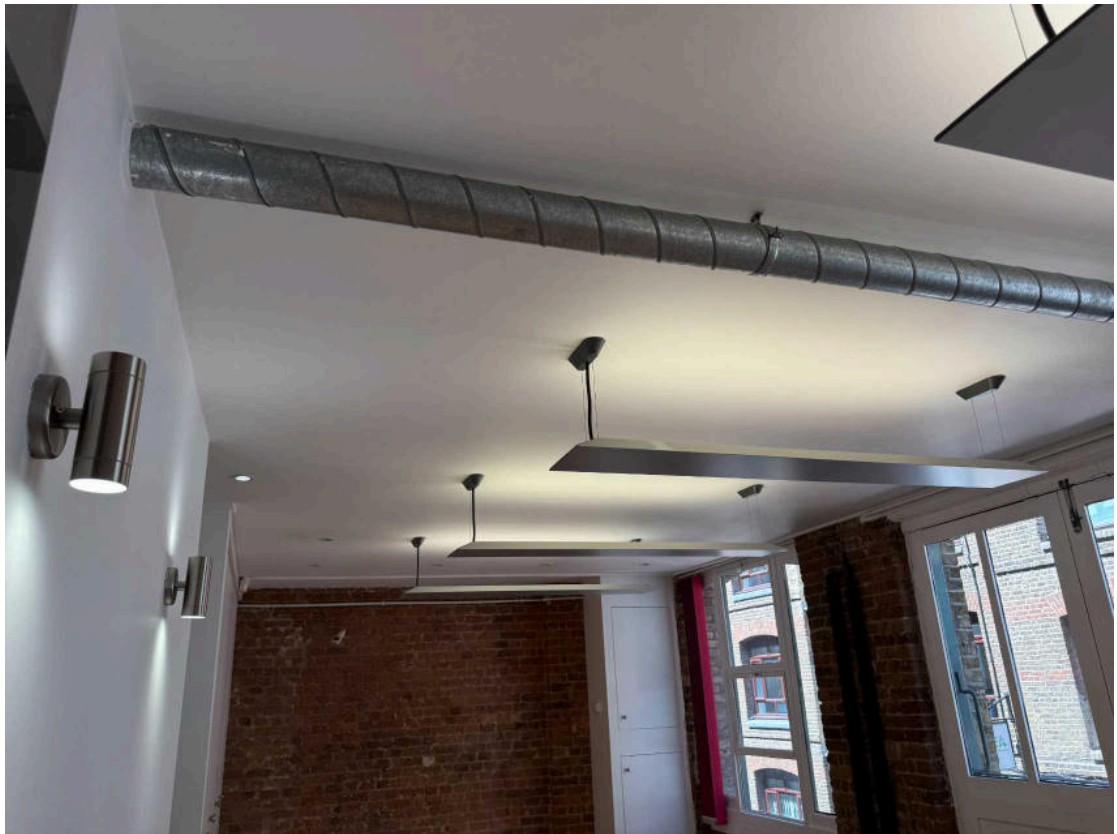
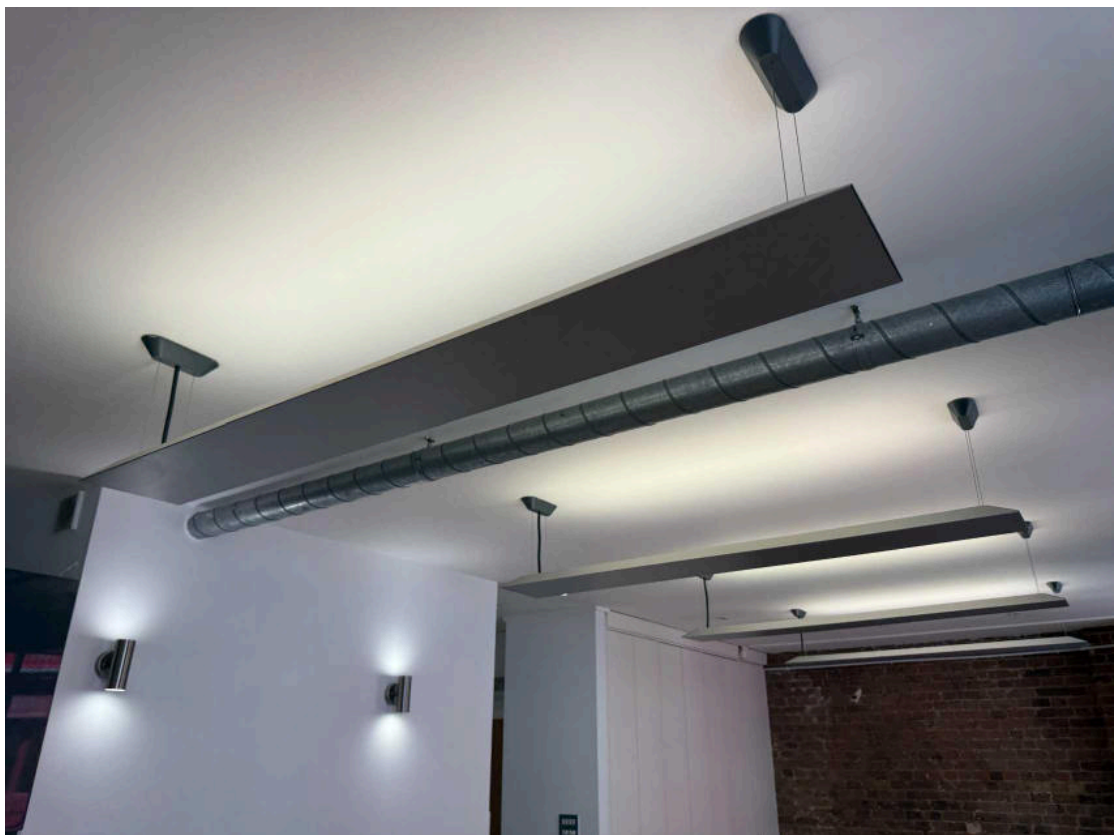
It should be noted that plasterboard ceilings are prone to joint and shrinkage cracks. Minor cracks are noted in the ceiling surfaces, which may be caused by general shrinkage and the normal vibrations, thermal movement, and settlement over the years, which tend to occur in domestic buildings of this type. These cracks are not of structural significance but will need to be filled when redecorating.

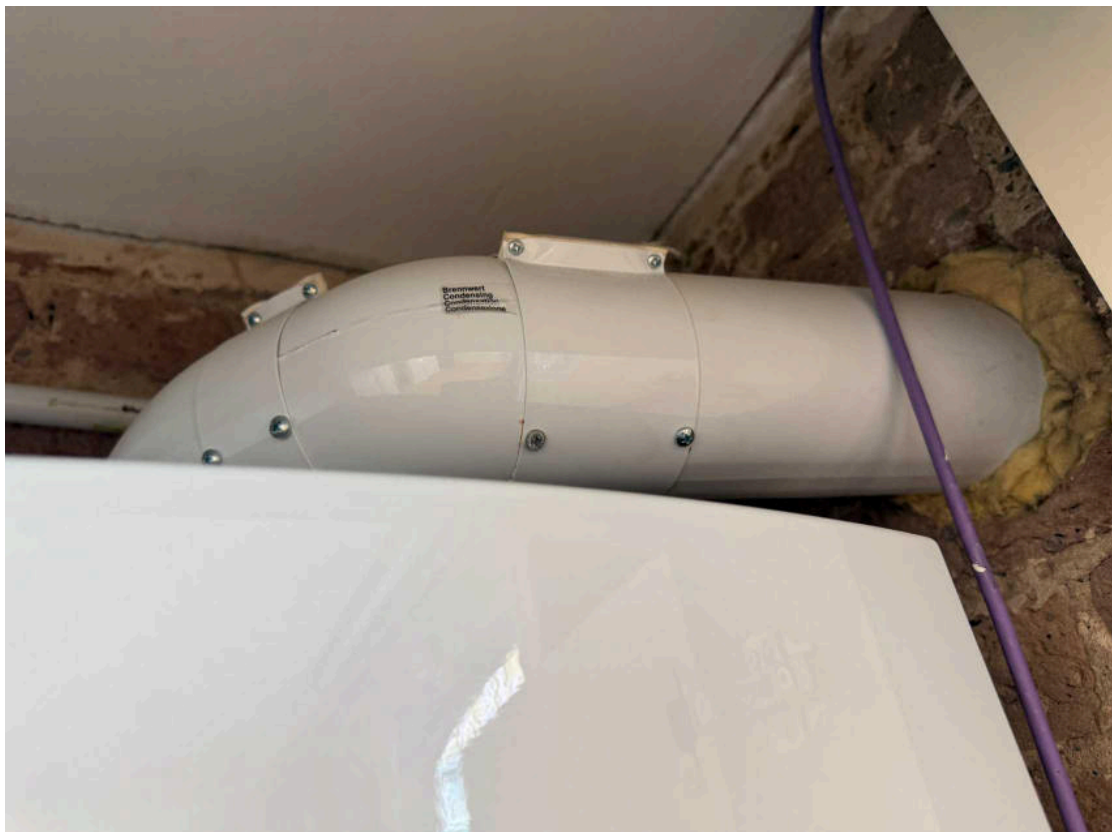
***Central heating boiler flue***

The central heating boiler flue appeared clear and unobstructed and should always be kept so. Adequate ventilation must be provided to ensure there is sufficient oxygen during the combustion process to prevent the production of carbon monoxide as opposed to carbon dioxide, the former being toxic. This is a mandatory requirement under the Gas Safety Regulations.

A GAS SAFE registered engineer should be called in to fully determine the condition of all gas appliances/pipework within the property to ensure their compliance with all regulations and requirements, and the adequacy of flues to accommodate exhaust emission arrangements.

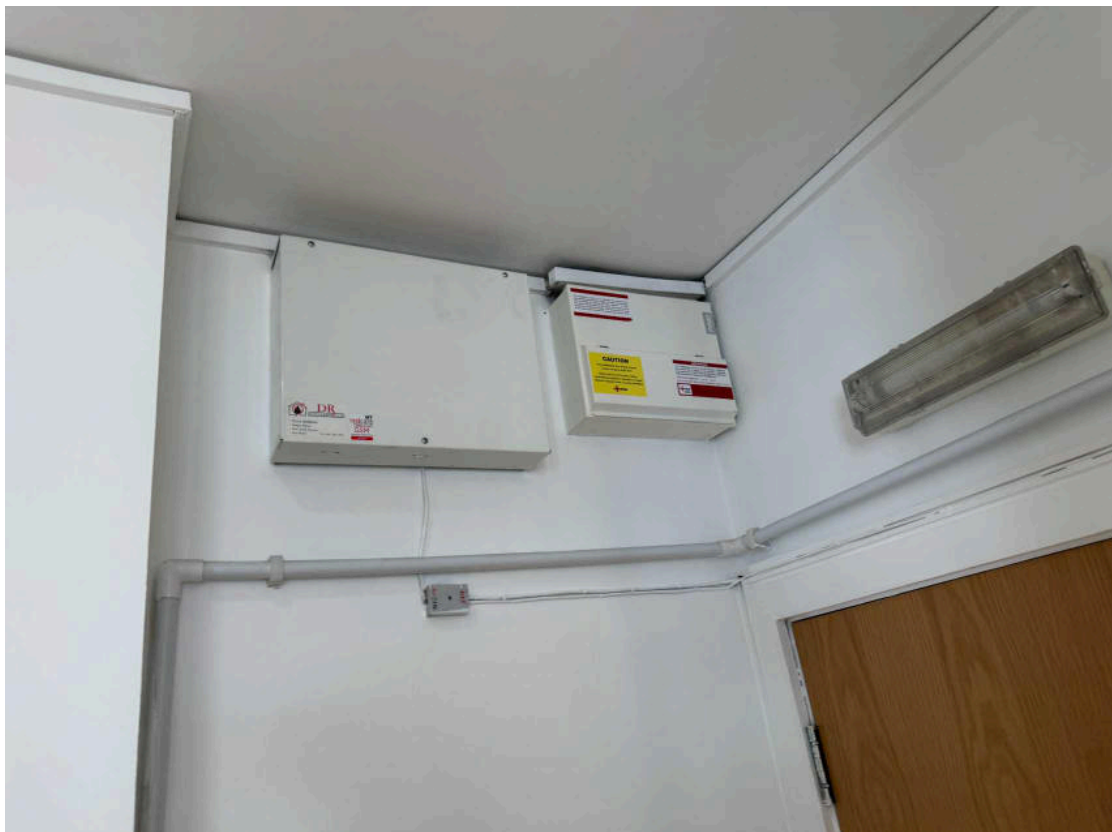
### **Consumer unit**

Condition rating 3: A test is recommended, and confirmation should be obtained that the installation was carried out by an NICEIC-registered electrician.

You are advised to instruct a qualified NICEIC/NCA registered electrical contractor to test the electrical circuitry and heating system and report their condition together with a quotation for any repair/renewal required. See Sections J1 and J3 Risks.

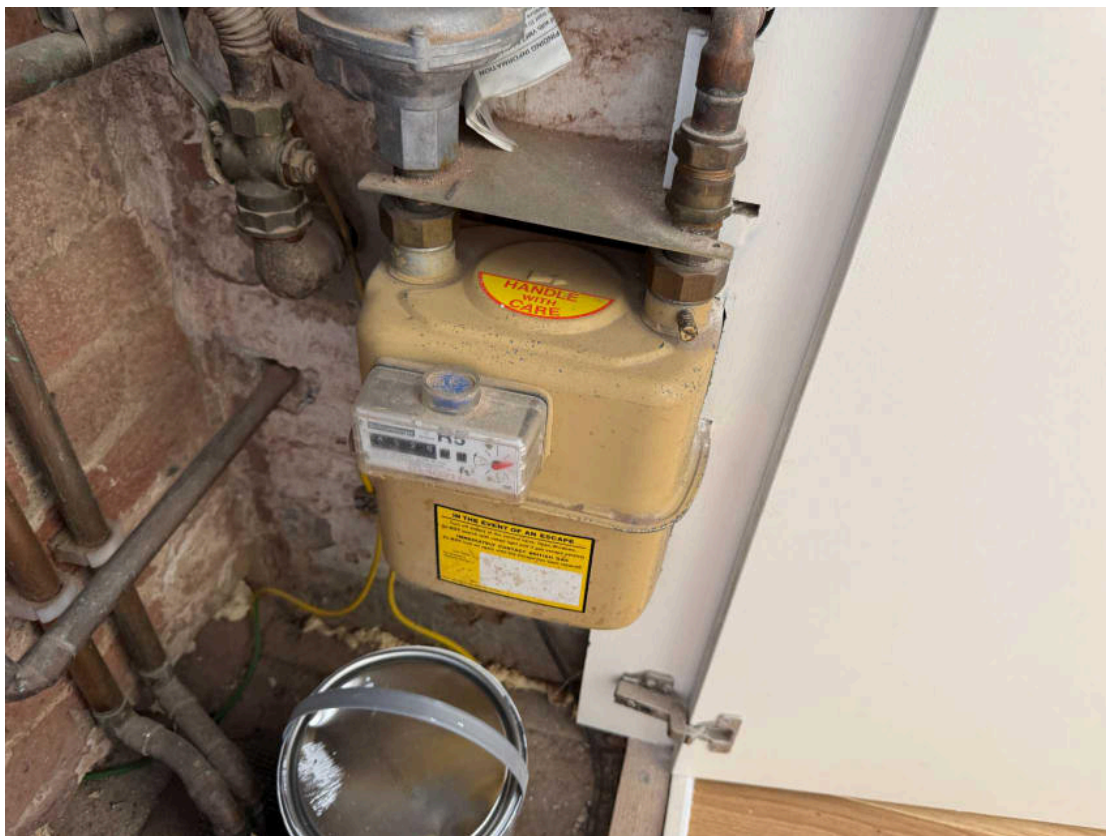
**Gas meter**

Condition rating 3: A test is required.

It should be noted that all alterations or installation of pipework must be carried out by 'Gas Safe' registered contractors. You are advised to obtain a report and quotation from a Gas Safe registered engineer in respect of gas installations on the property.

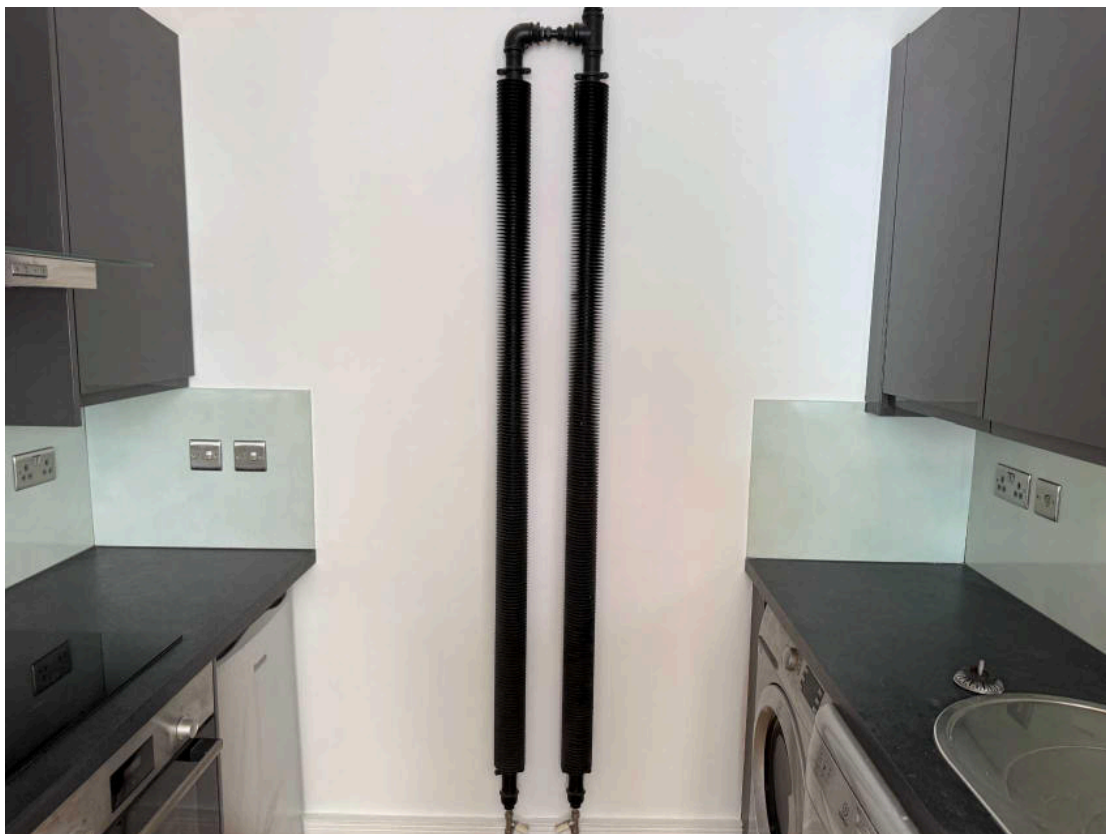
***Central heating radiator***

Condition rating 3: A test is required.

It is recommended that service records be obtained, and if the boiler has not been serviced recently, an appropriately qualified person should be instructed to undertake a full service, including checking the ventilation to the boiler, in addition to checking and cleaning out the flues as found to be necessary.
