**RICS HOME SURVEY  
LEVEL 3**

■■■■■  
■■■■■■■■■■  
London  
E10 ■■■■

■■■■■ ■■■ January 2026

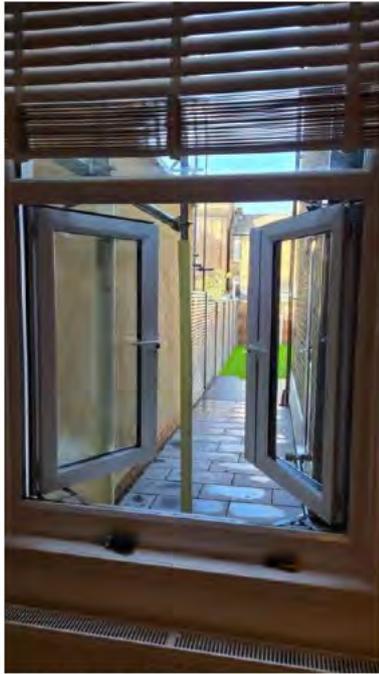
The windows have been replaced incorporating uPVC double-glazed windows, to which no significant defects were noted. The double-glazed units should have been installed by a FENSA registered contractor or any other UKAS-approved certification body. If no FENSA installation certificate is available, the installation may not comply with Building Regulations. Legal Advisors to confirm if a FENSA certificate is available. See Section I3.

There were no signs of condensation between the double-glazed panes at the time of inspection. It should be noted, however, that double-glazing can be prone to this problem, which is caused by a failure of the seals at the edges of the panes of glass. Over a period of time the seals can deteriorate, causing unsightly condensation or misting between the panes. When this happens there is no remedy other than to replace the defective double-glazed panes.
