RICS HOME SURVEY LEVEL 2

- SURVEY & VALUATION

■■■■ Court
■■■■
London
E1 ■■■■

■■■■■■■■ November 2025

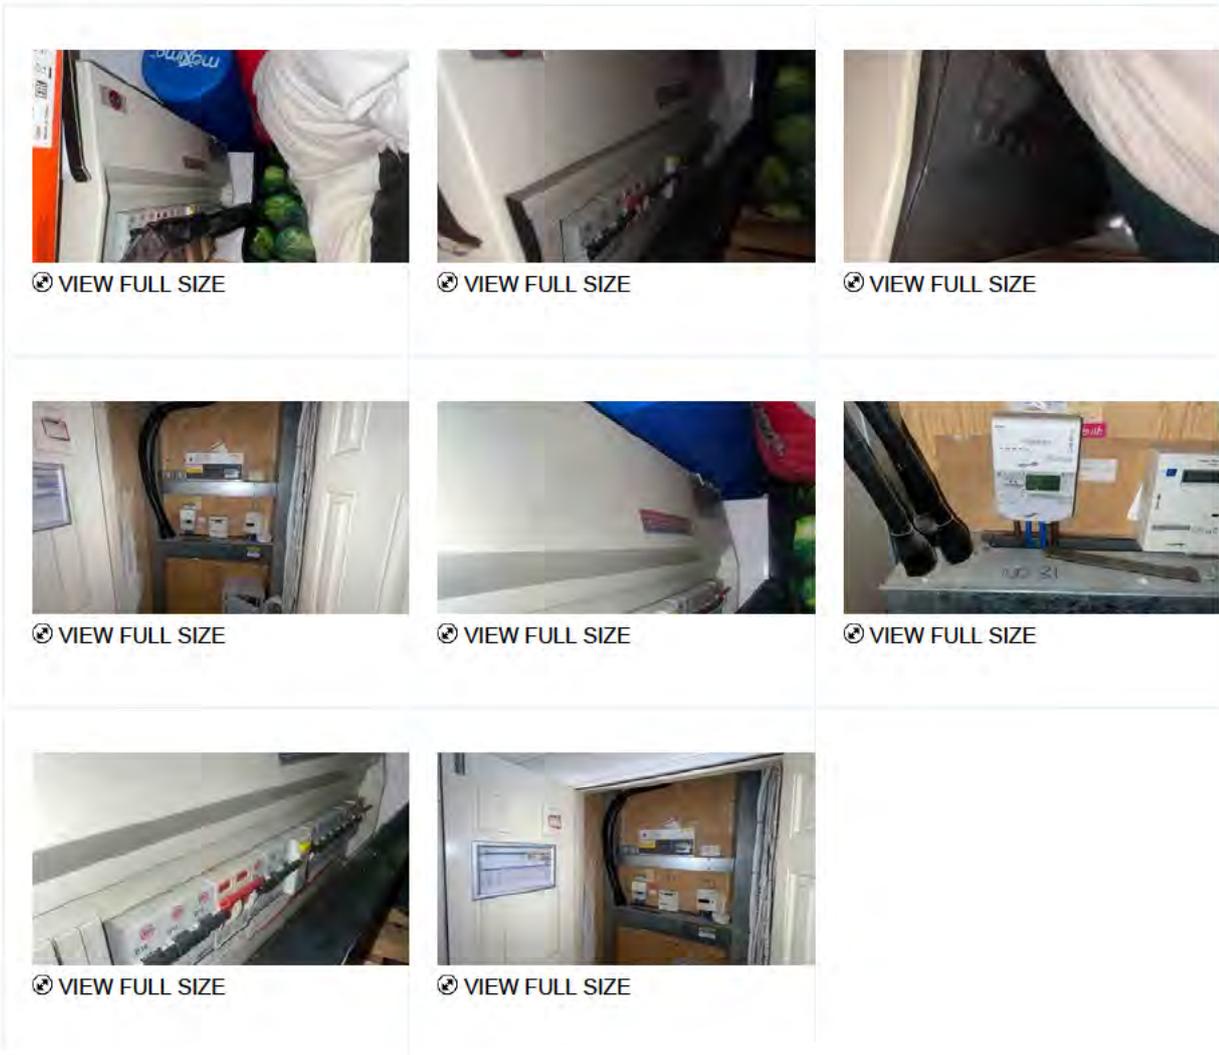
The electrical installation is provided with an RCD which is designed to protect the users from electric shock. These installations are extremely sensitive and consequently occasional tripping of switches will occur, effectively shutting down the affected circuit(s). It can often result when a light bulb fails, or it may be the result of a defective appliance. When this happens, the 'trip-switch' must be reset. If this occurs with any frequency, an electrician should be instructed to investigate.

There is an electric hob fitted and you should confirm with your Legal Advisor whether this has any electrical safety certification.

Condition Rating: **3**

- Undertake a precautionary test of the electric hob prior to purchase
- Arrange for a test of the dated electrical heating prior to purchase, with recommendations for upgrade fully costed
