## **SCHEDULE OF CONDITION**

■■ Morley Road,  
London,  
E15 ■■■■

This schedule relates to the left-hand side wall of [REDACTED] Morley Road, London, E15 [REDACTED].

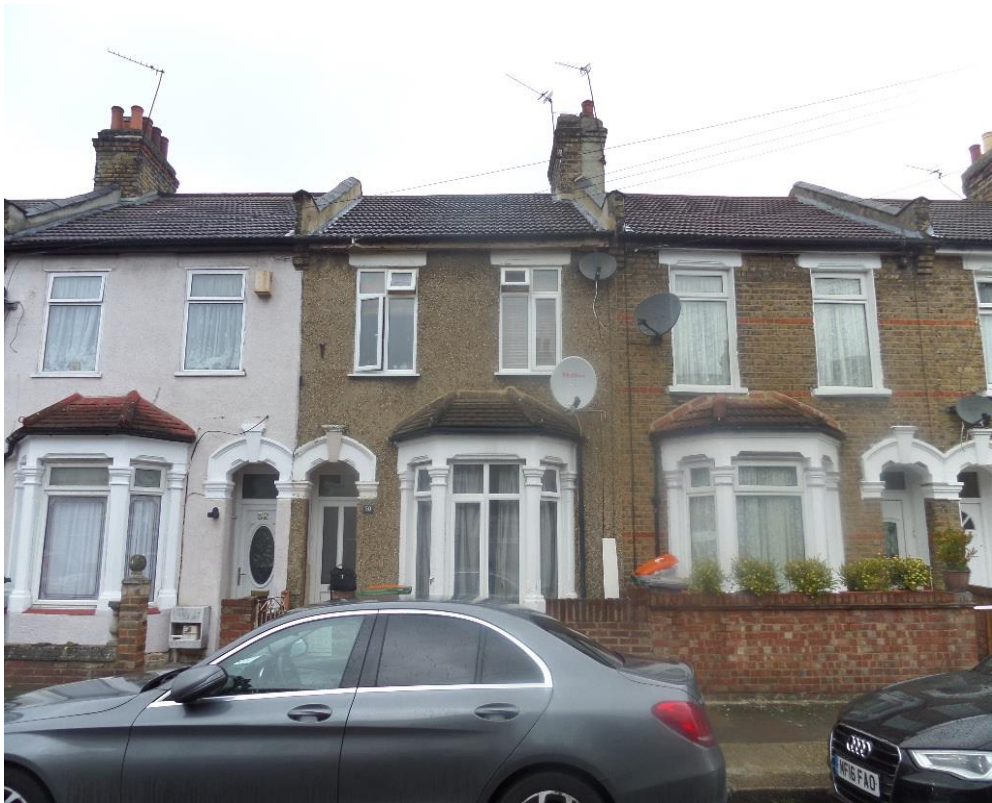
External wall (front).

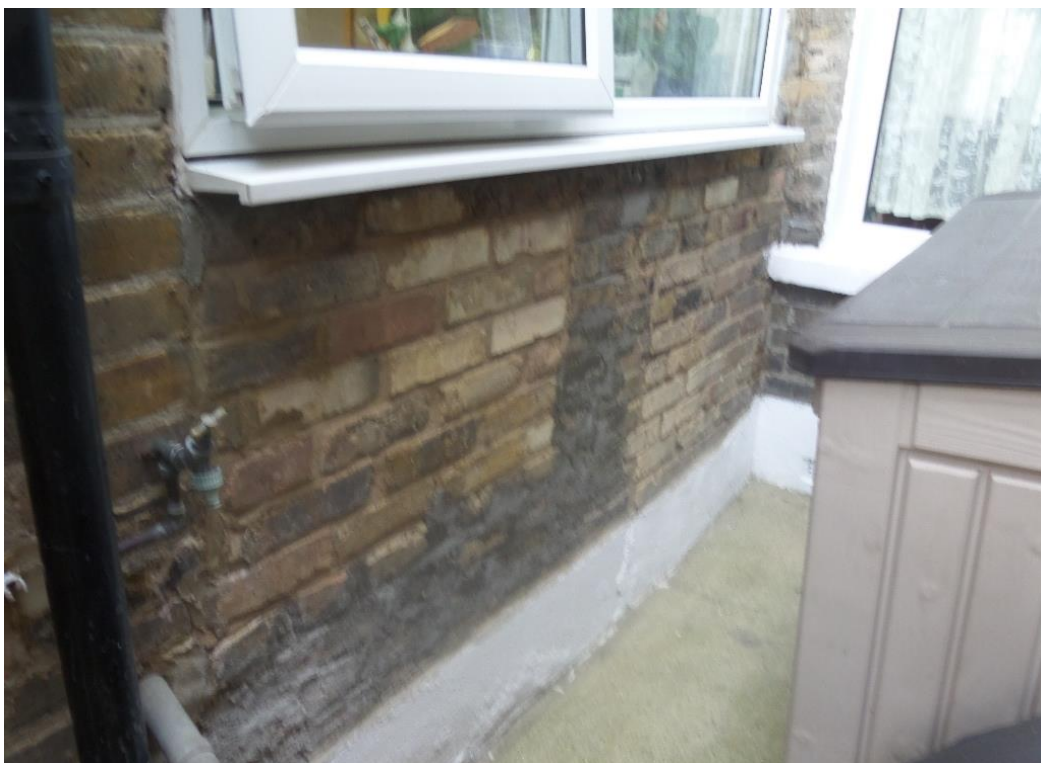
| <b>Item</b> | <b>Description</b> | <b>Condition</b> |
|---|---|---|
| WALLS | Brick masonry walls. | No significant defect, some distortions on the flank wall. |

External wall (left-hand side).

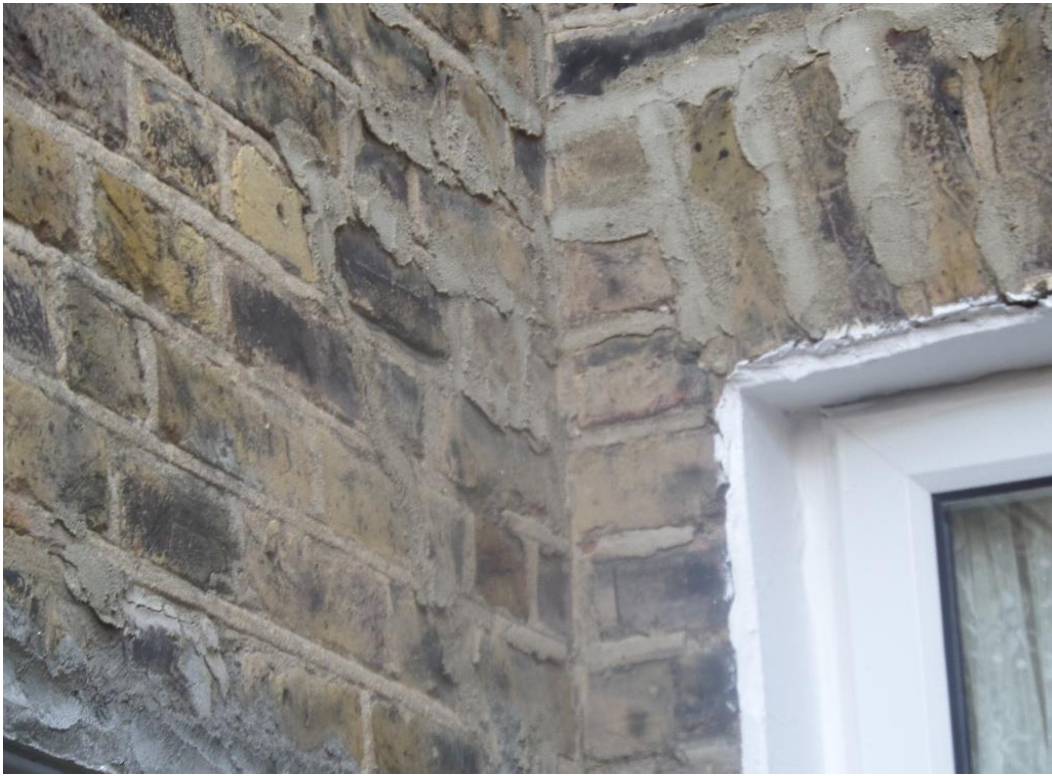
External wall (left-hand side).

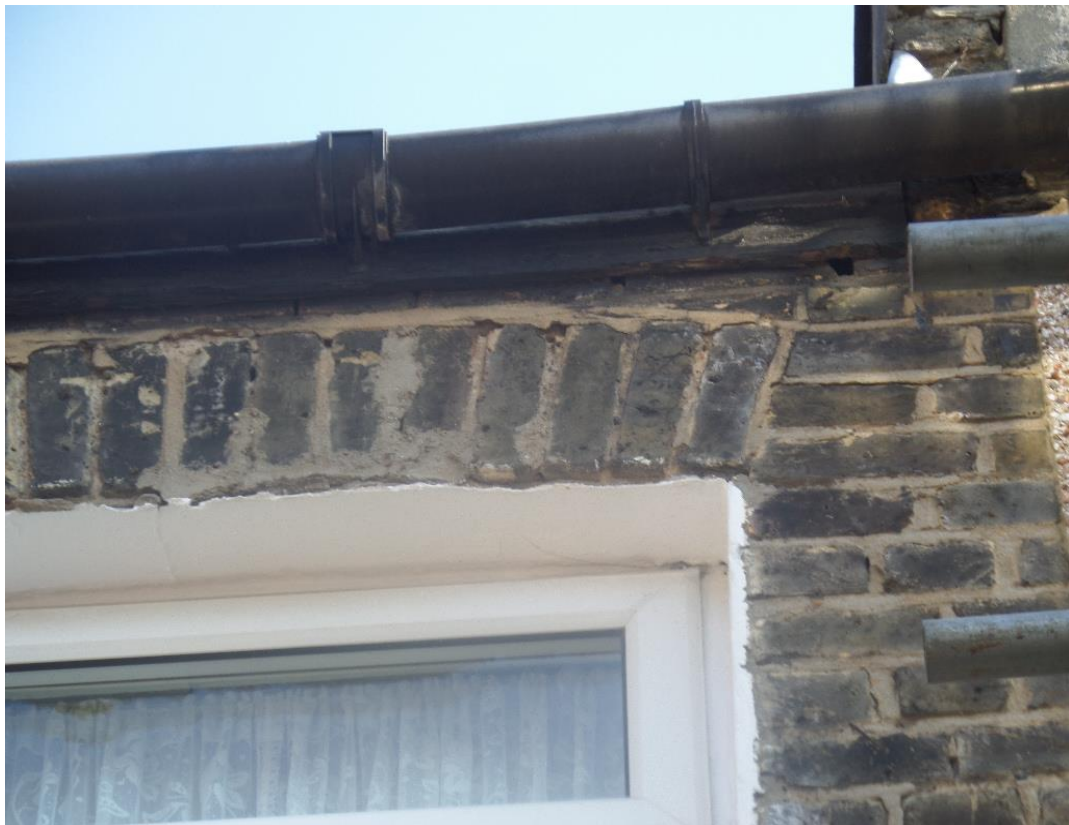
| Item | Description | Condition |
|---|---|---|
| | Front and rear elevation windows. | Vertical cracks on the reveals. Distortions on brick lintel. |

Distortion on brick arch lintel

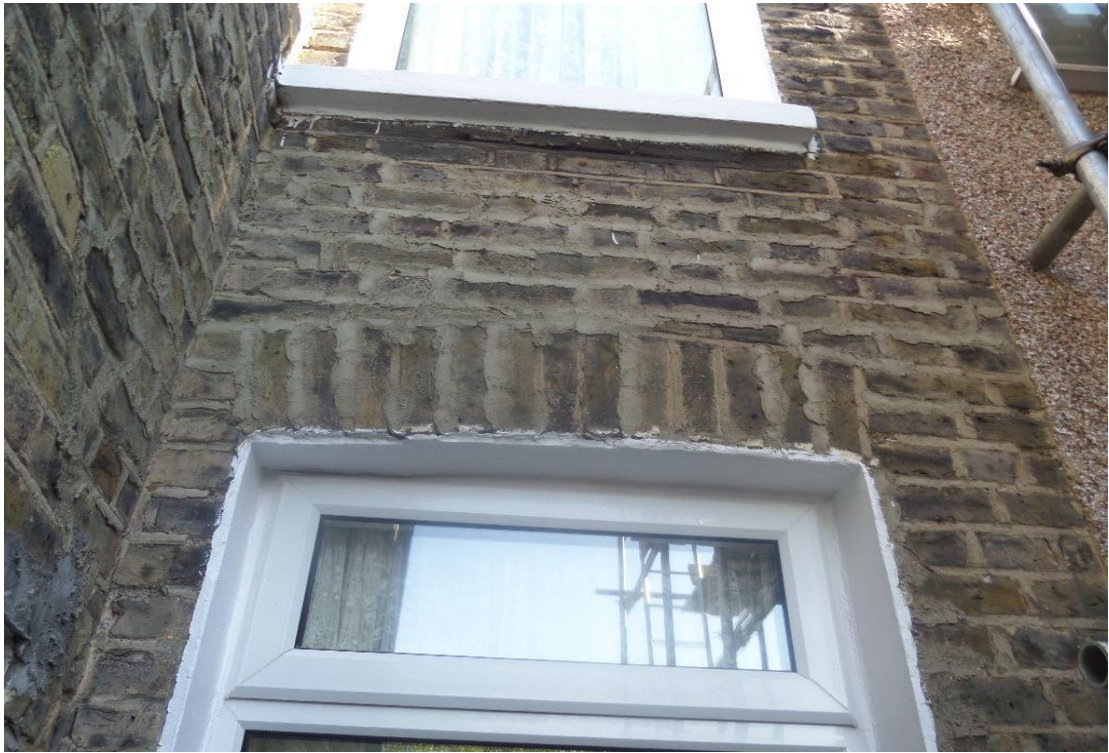
Distortion on the rear wall

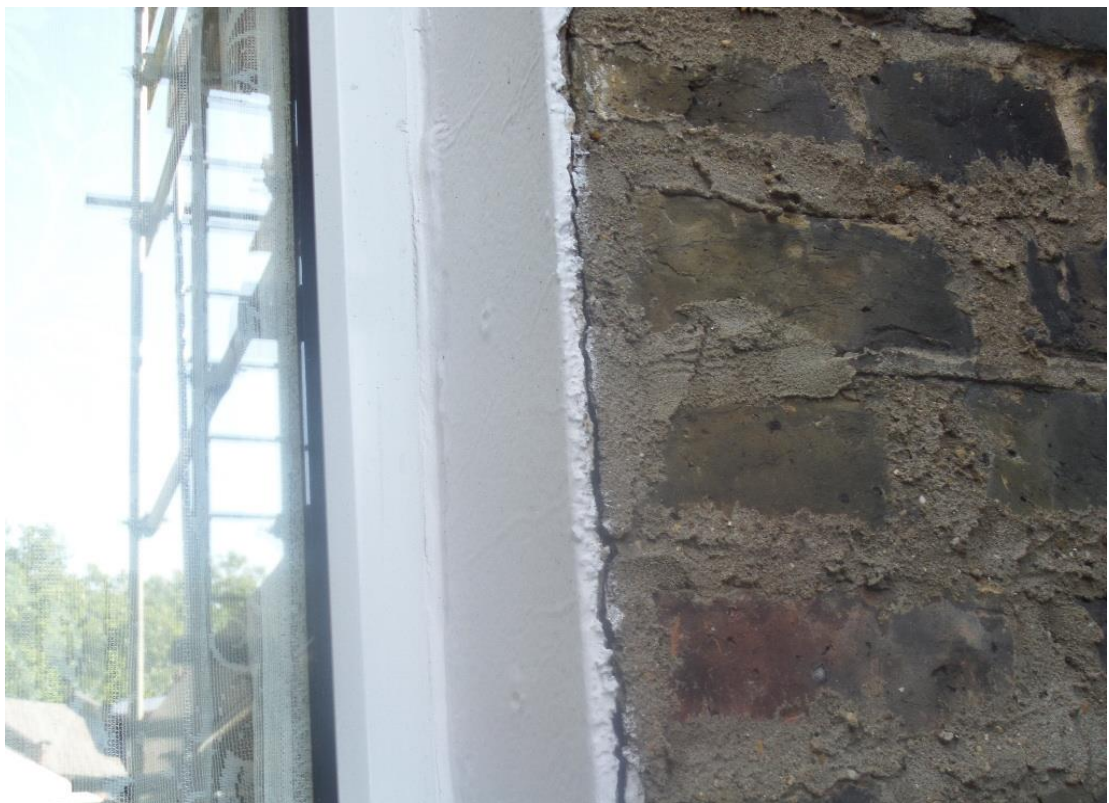
Cracks on reveal

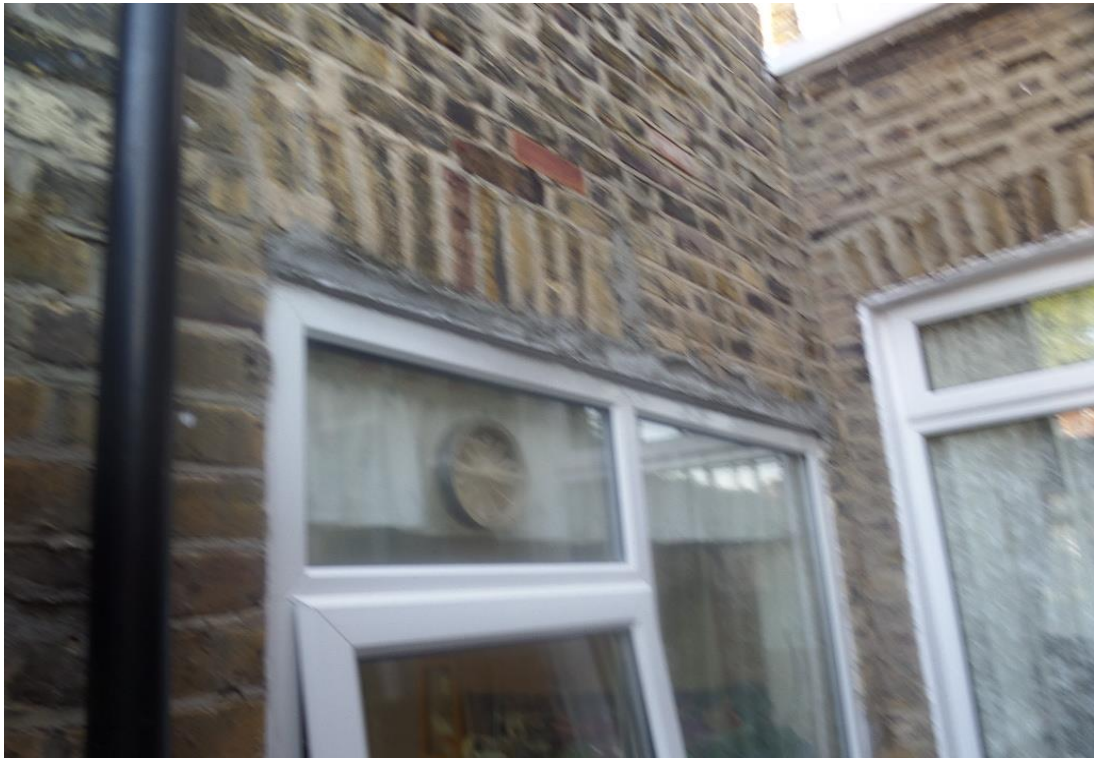
Distortion on the flank wall and lintel over the window

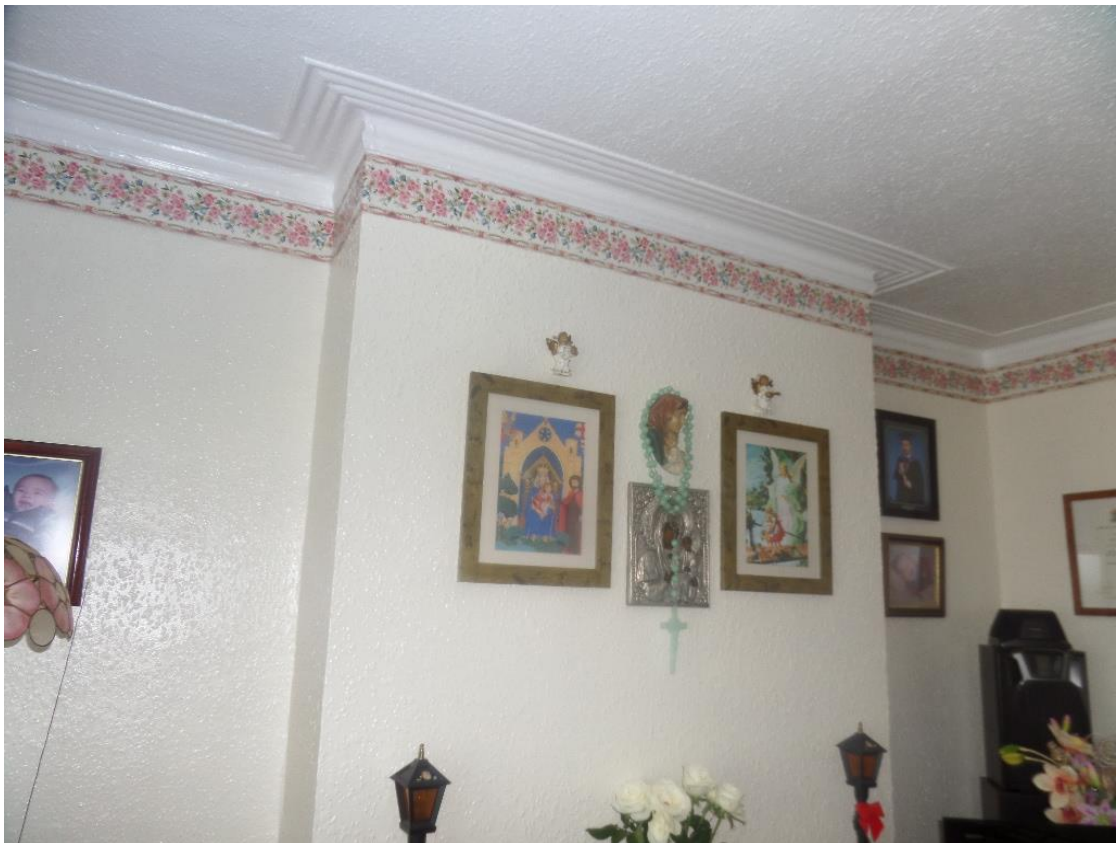
Reception room wall adjacent to the work site.

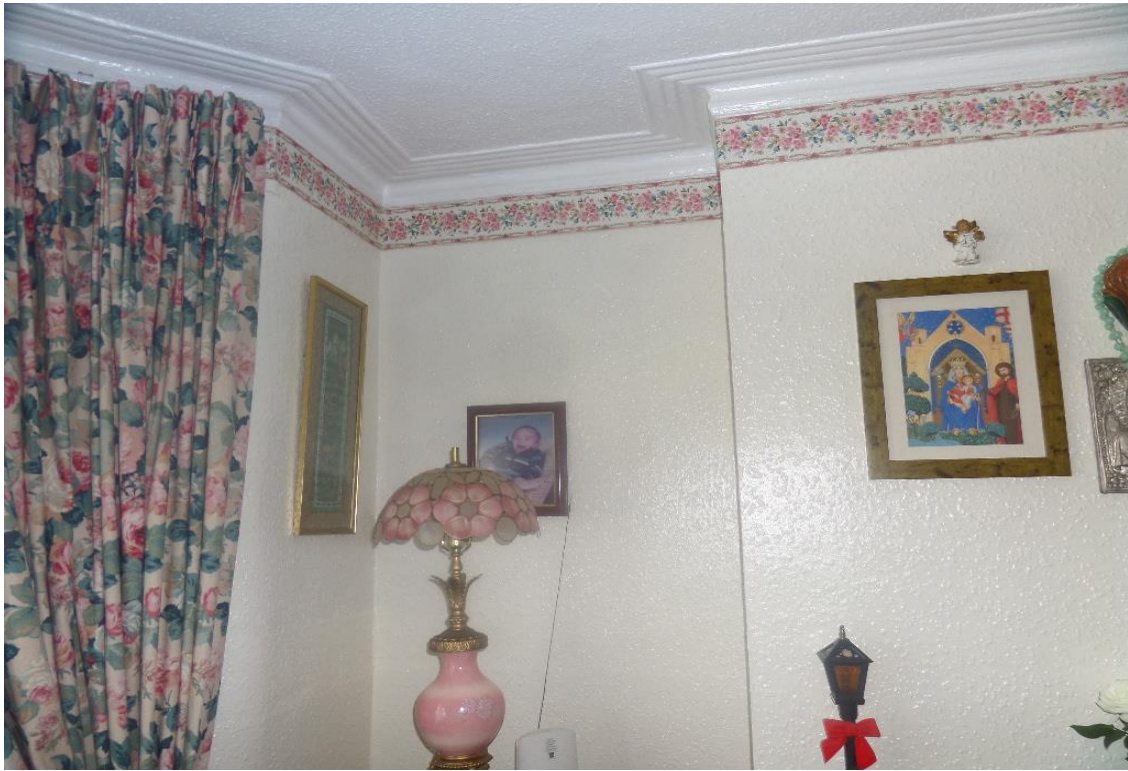
Reception wall adjacent to the work site.

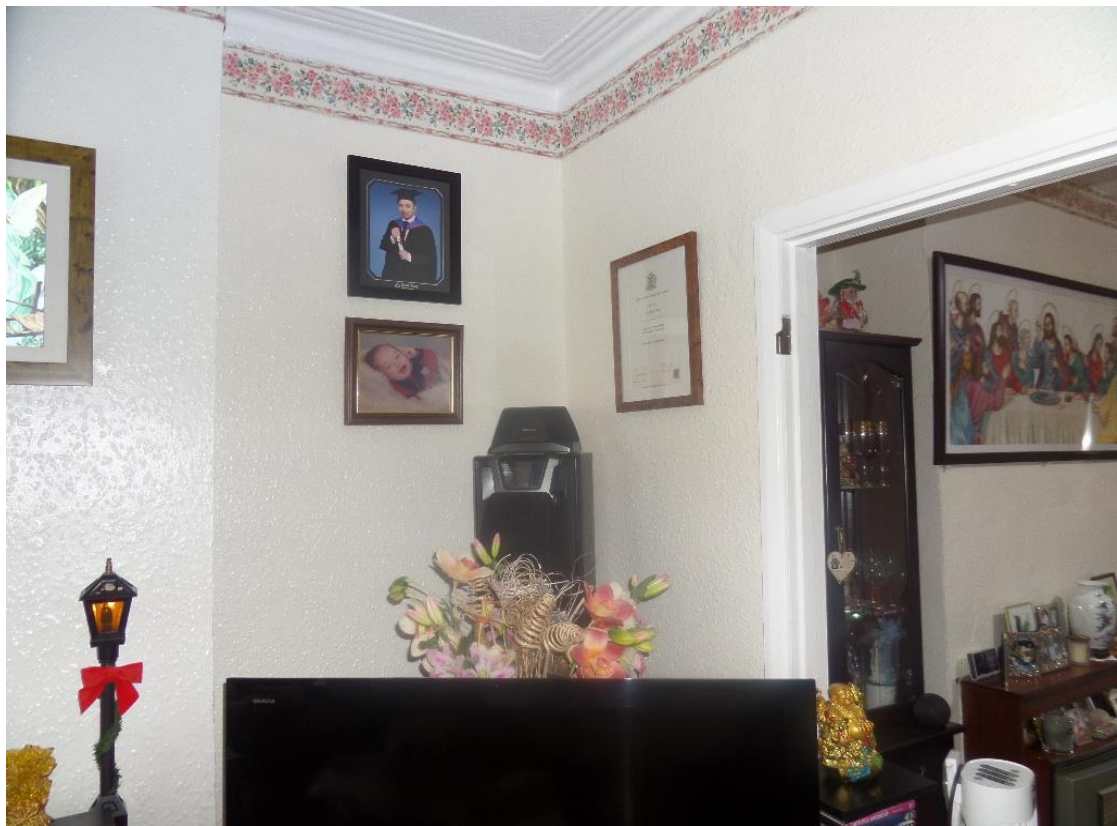
Rear reception wall adjacent to the work site.

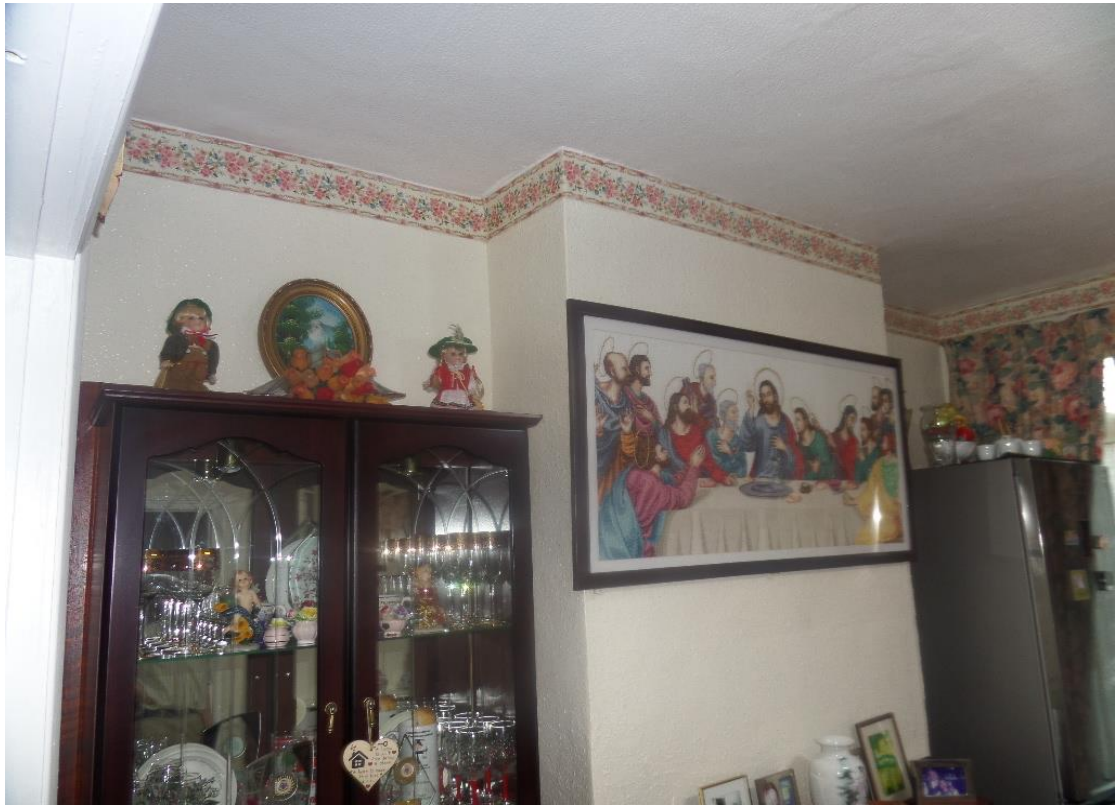
Rear reception wall adjacent to the work site.

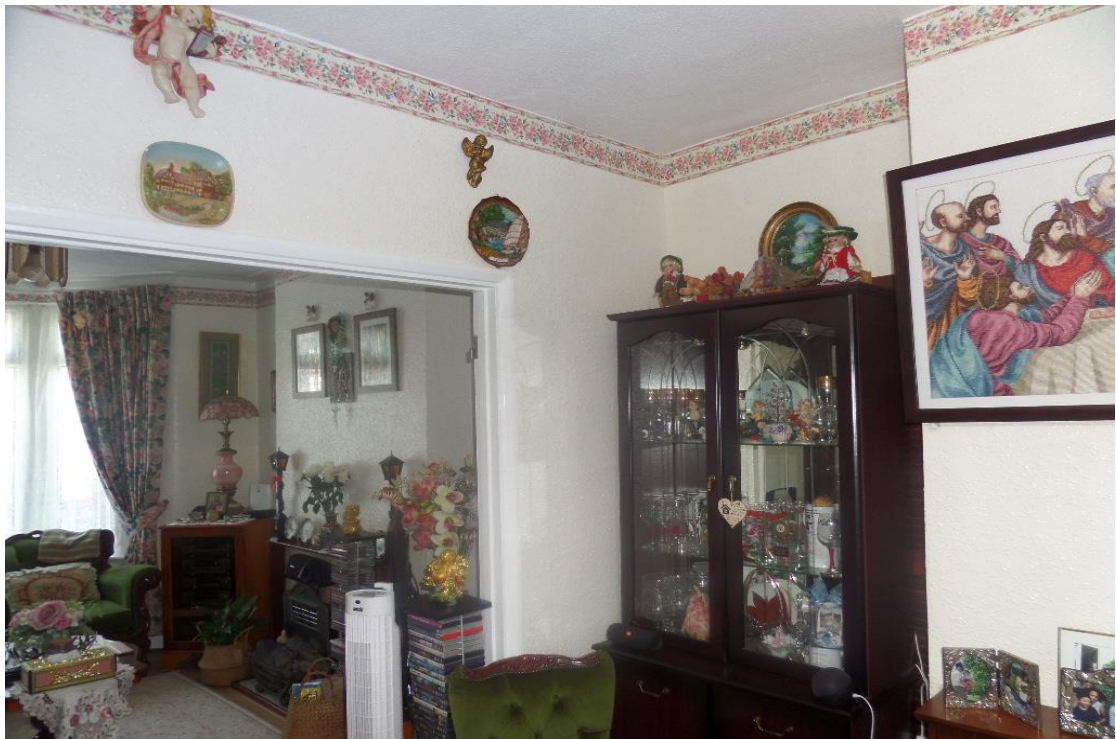
Rear reception wall adjacent to the work site.

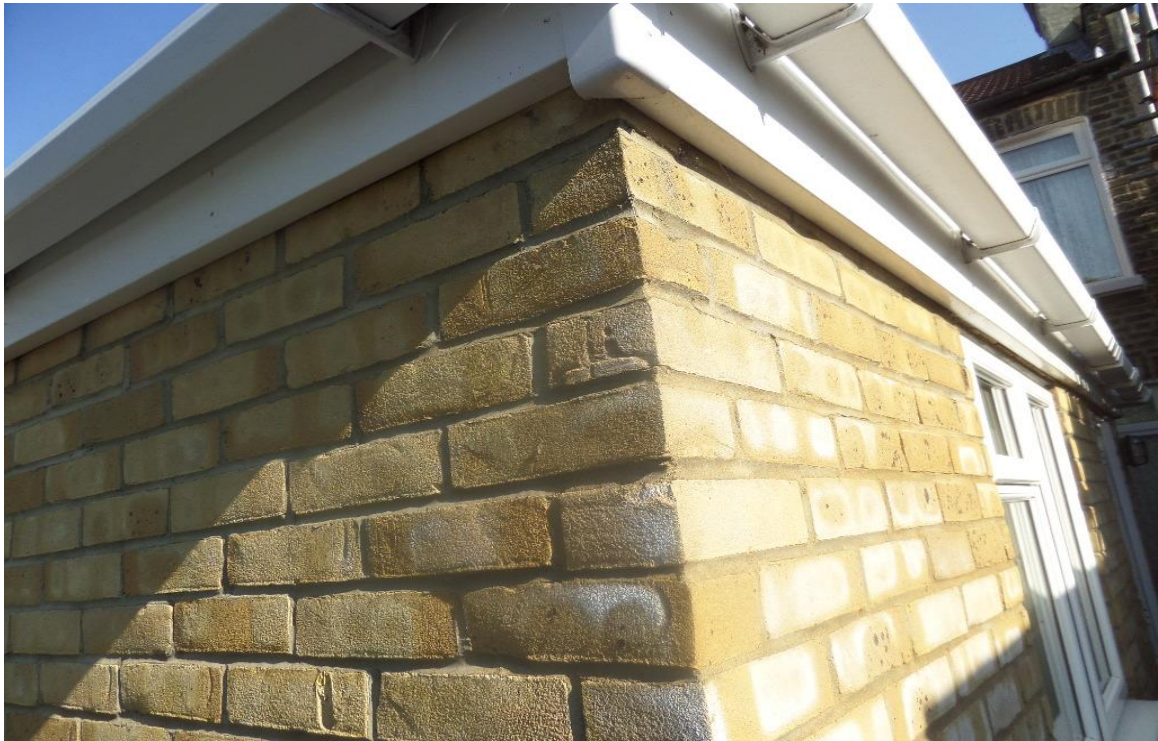
Rear extension wall adjacent to the work site.
