LEVEL THREE

# Your survey report

██████ Luke Street, London, London, United  
Kingdom, EC2A ██████

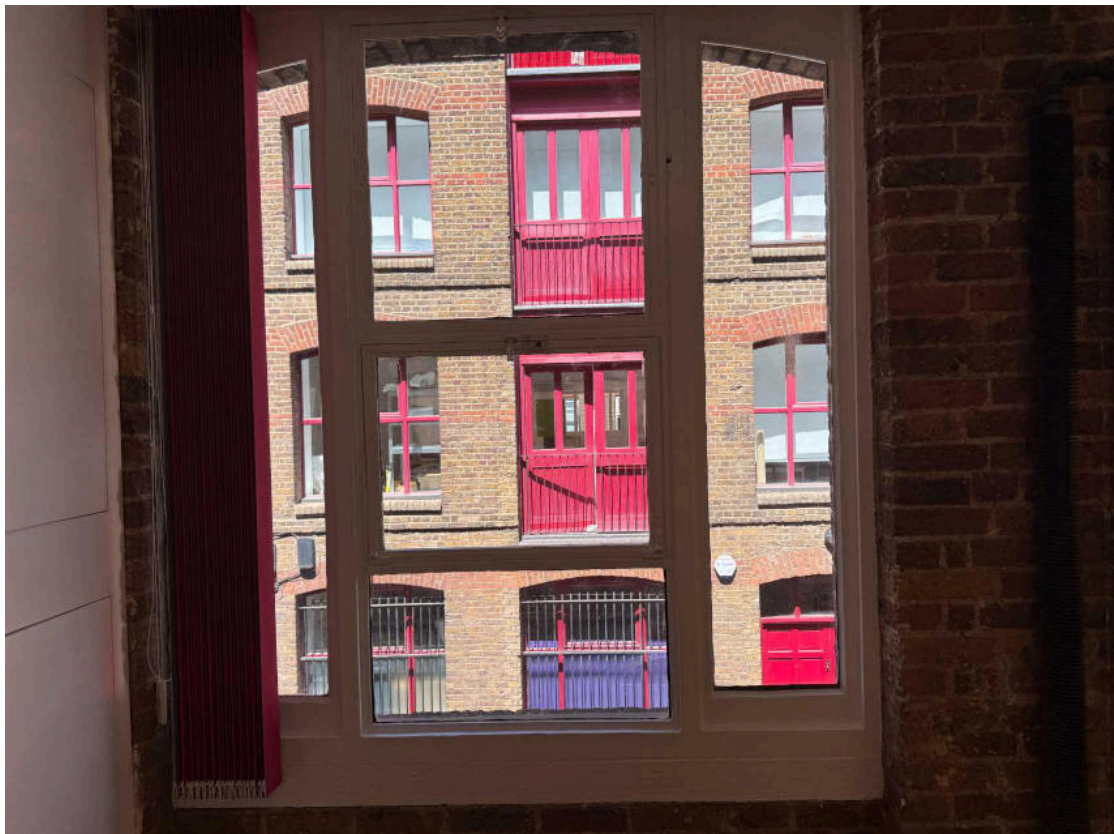
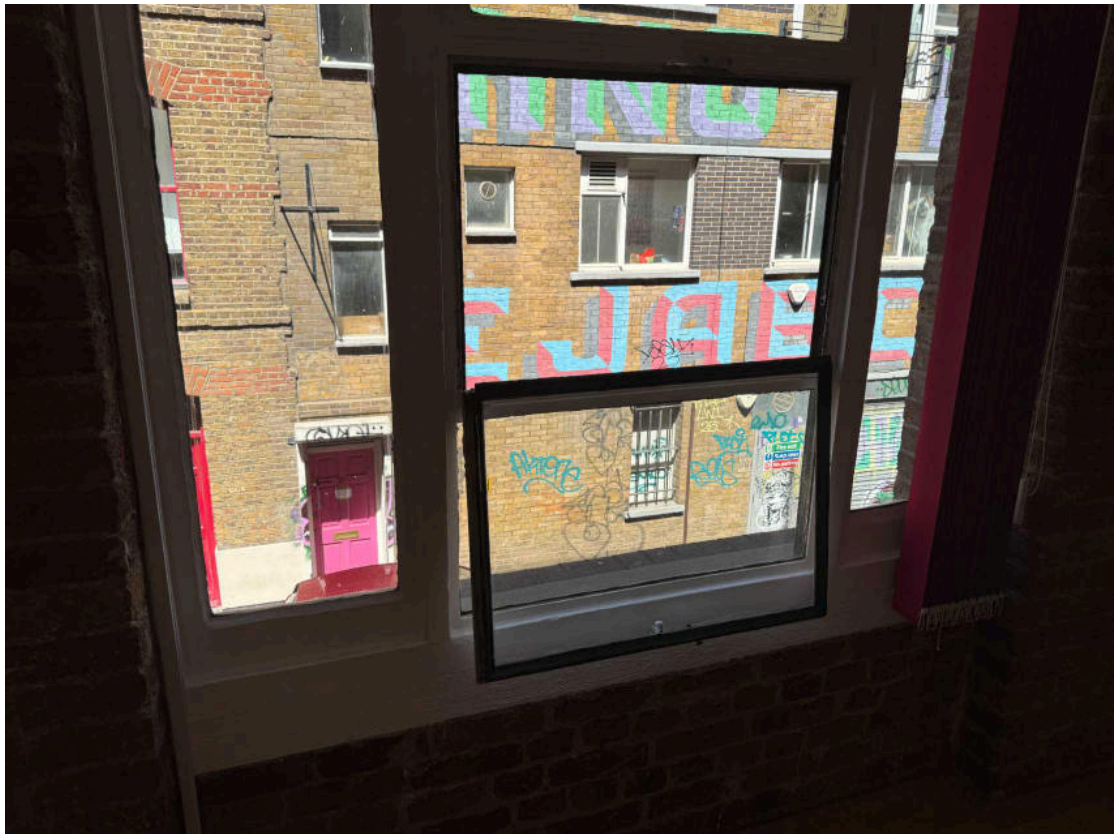
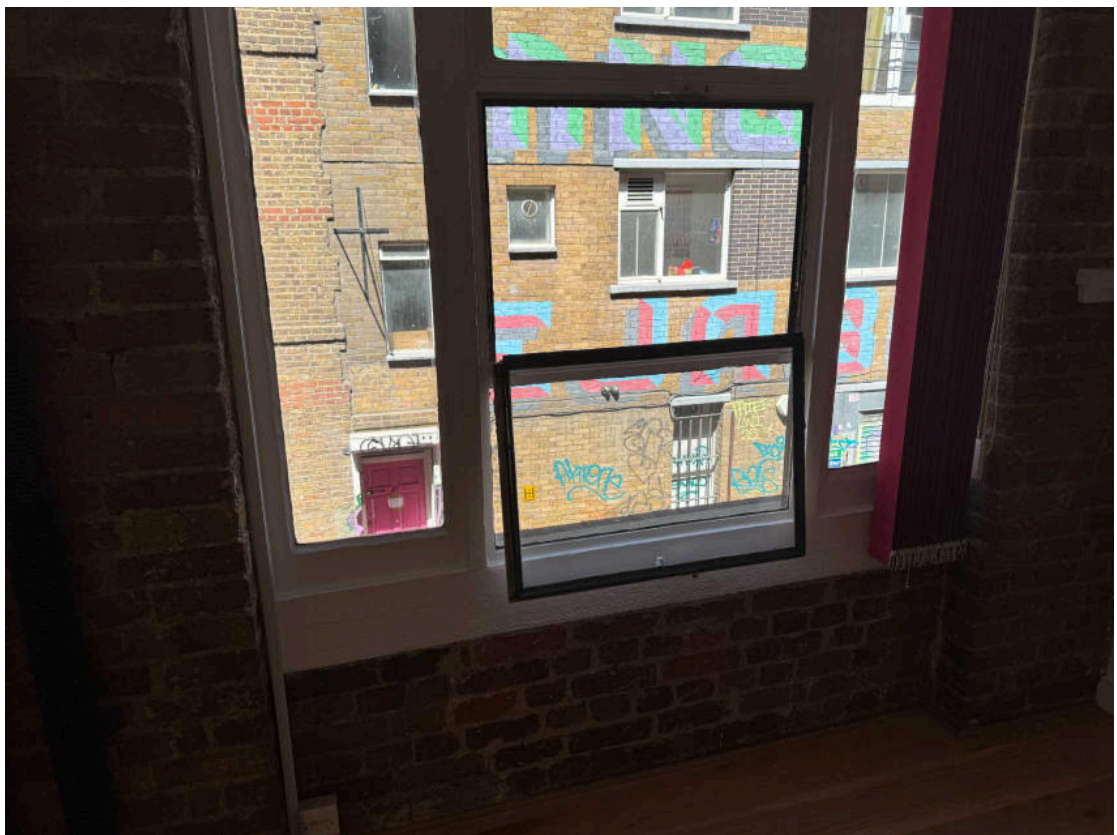
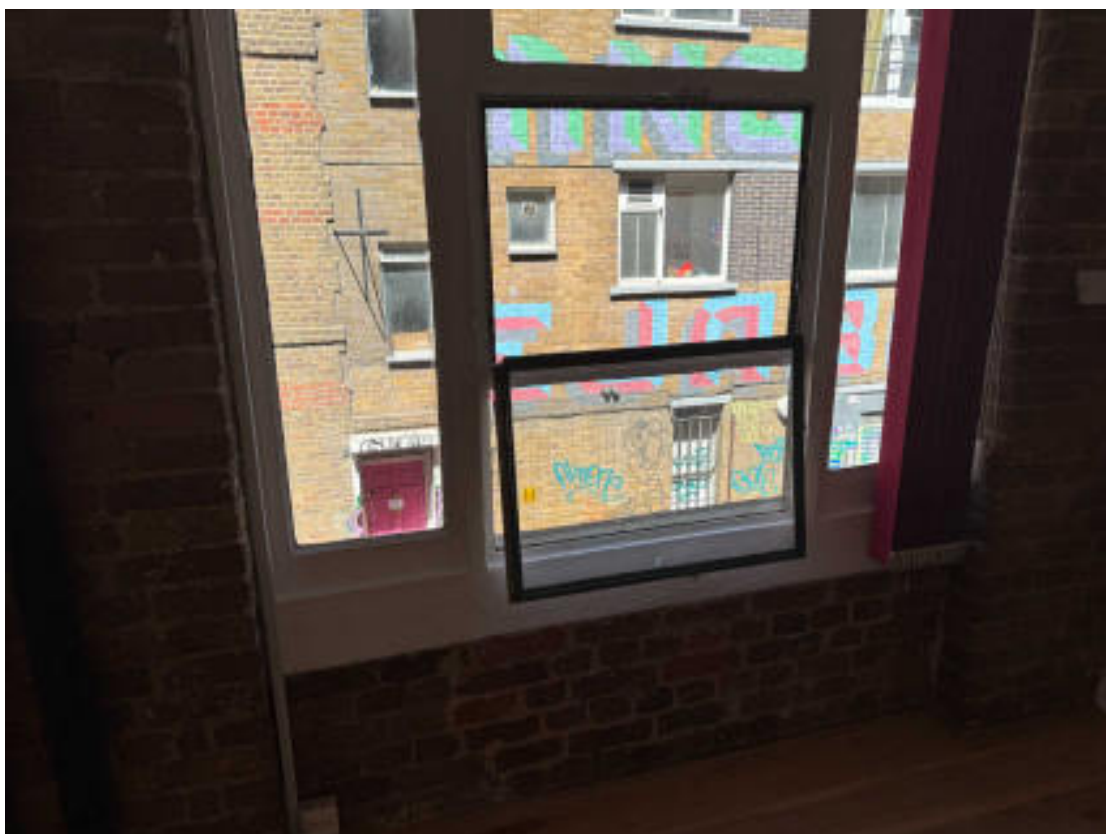
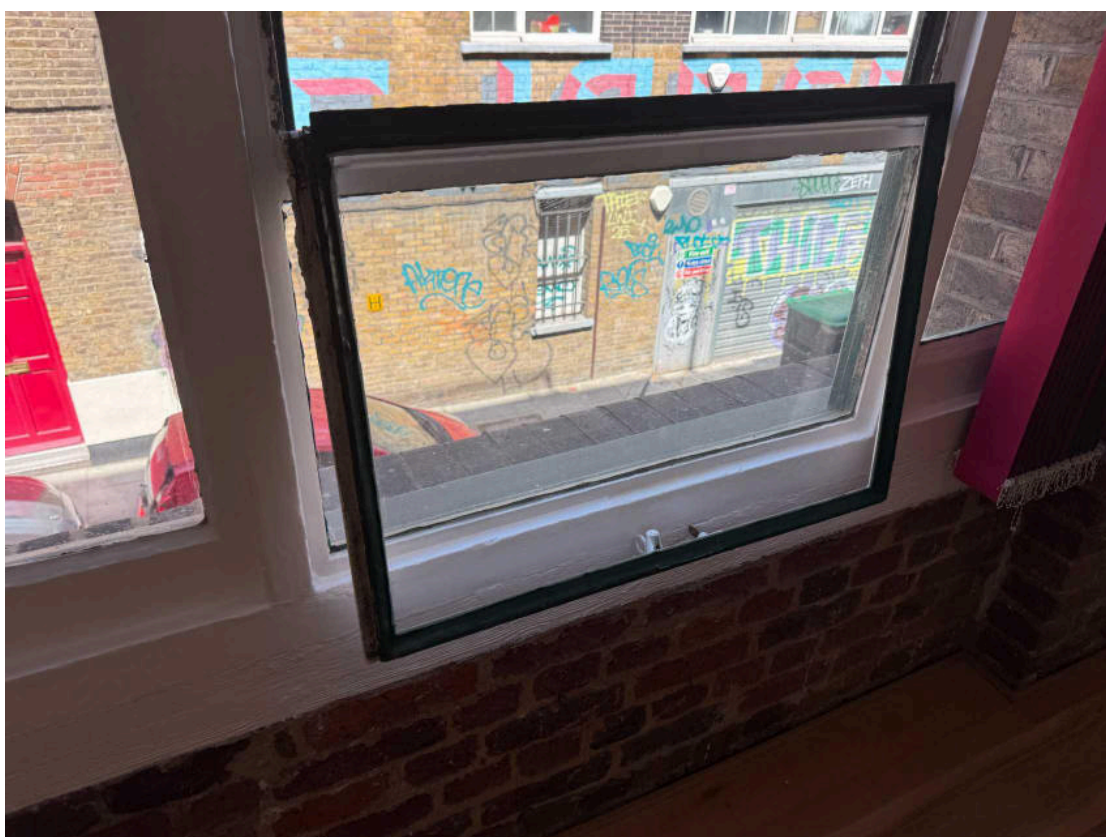
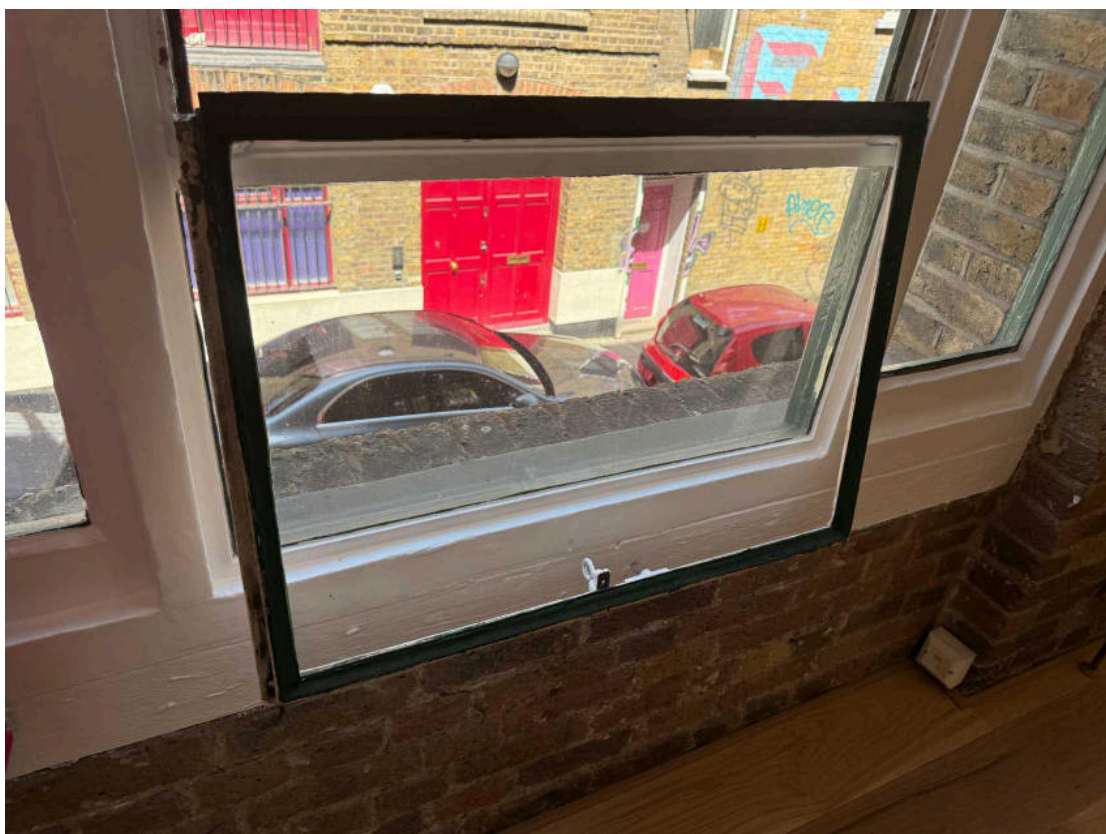
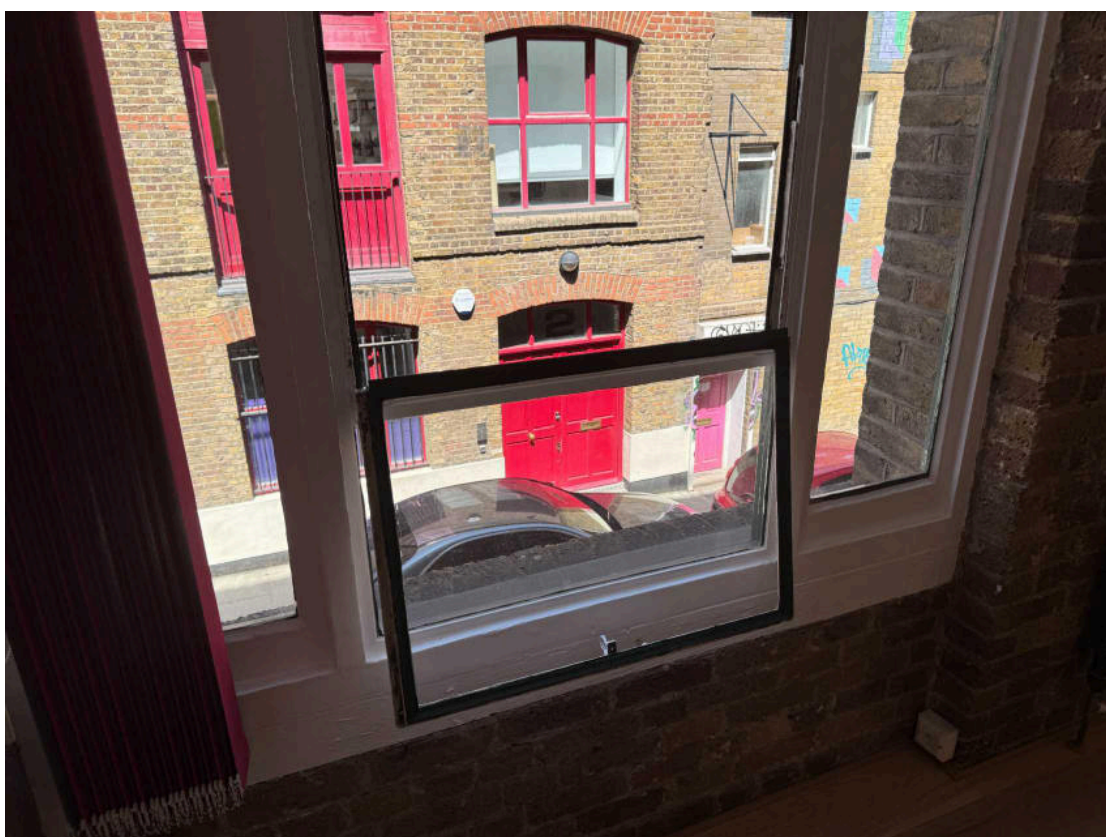
***Window***

Condition rating 1. No repair is currently needed. The property must be maintained in a normal way.

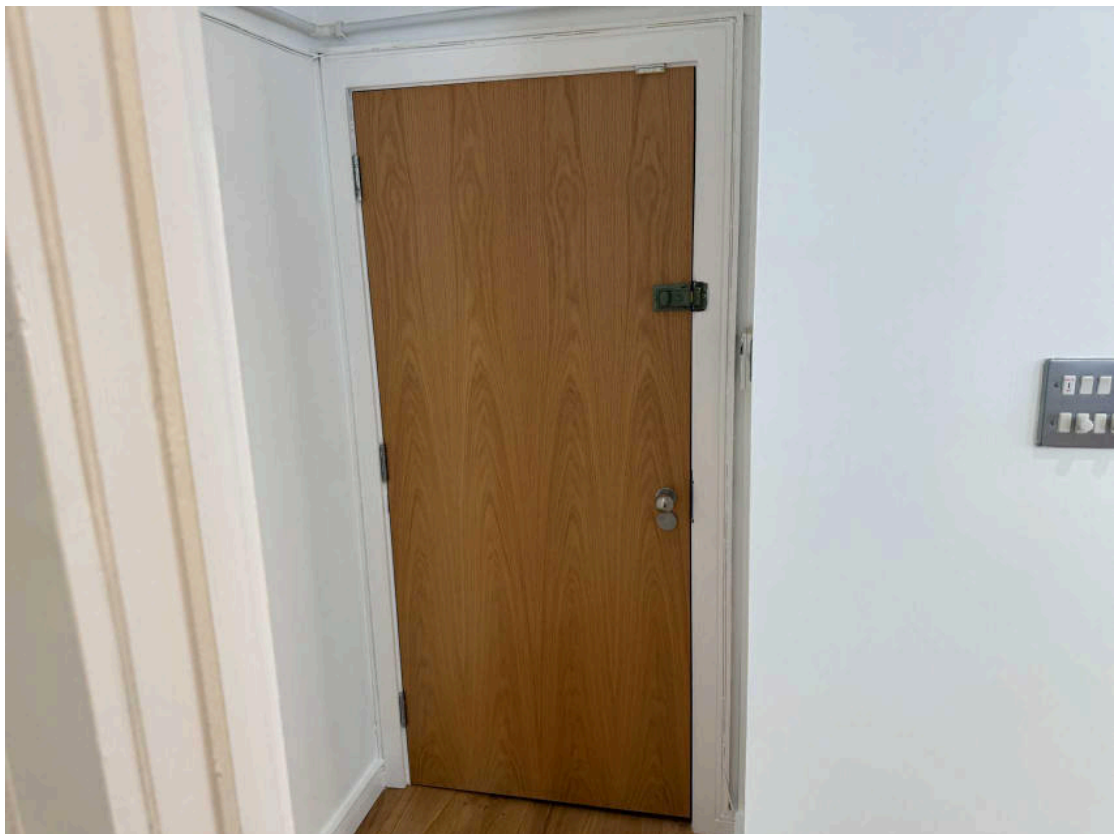
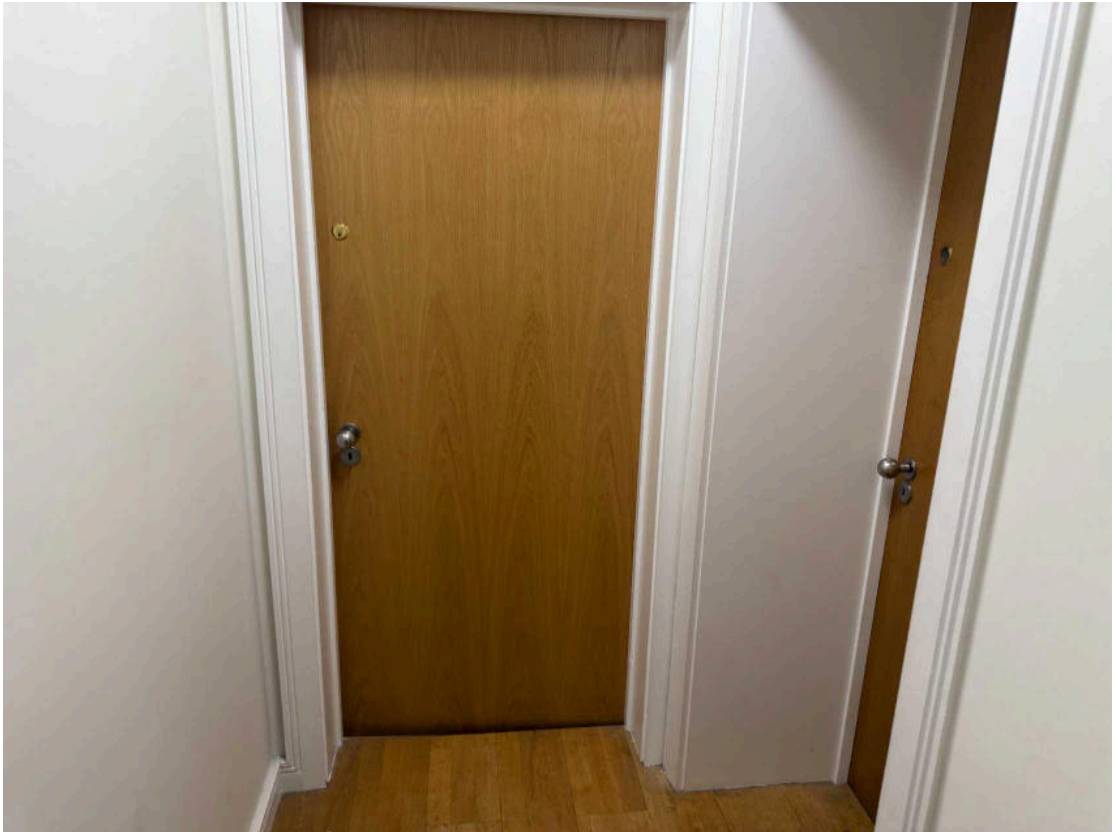
***Entrance door***

Condition rating 1: No repair is required, and the property should be maintained in a normal way.

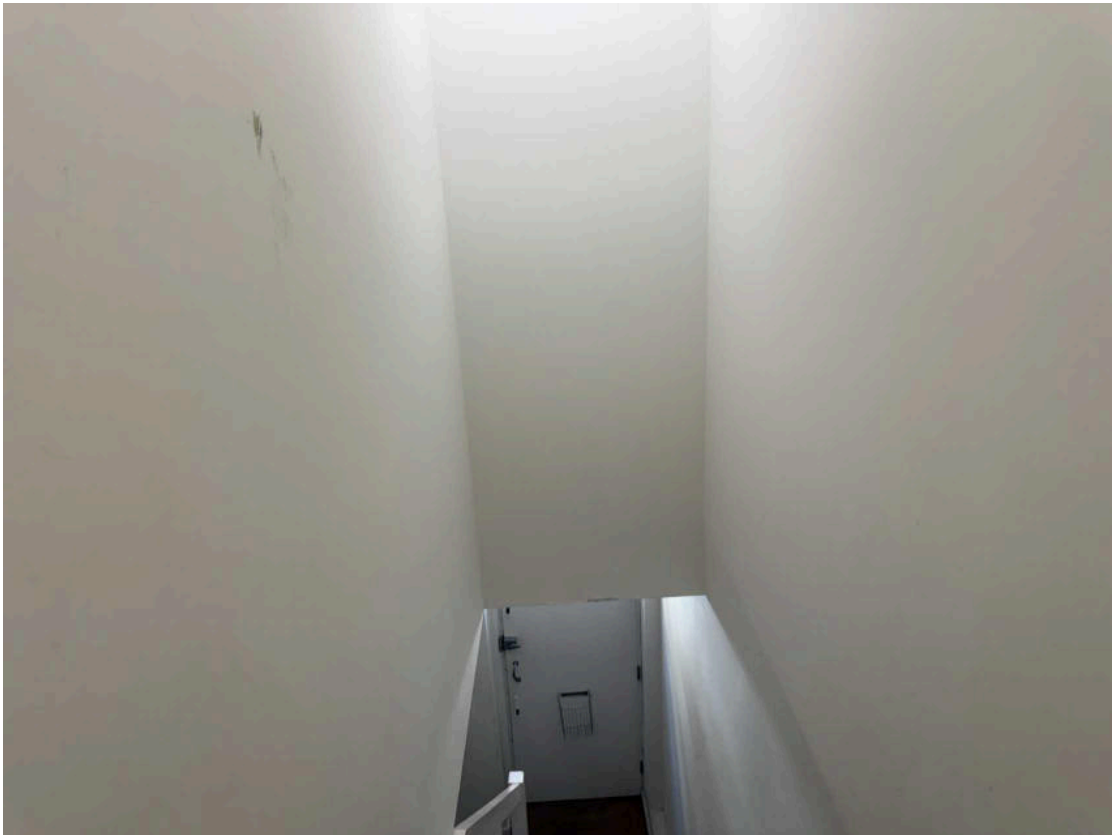
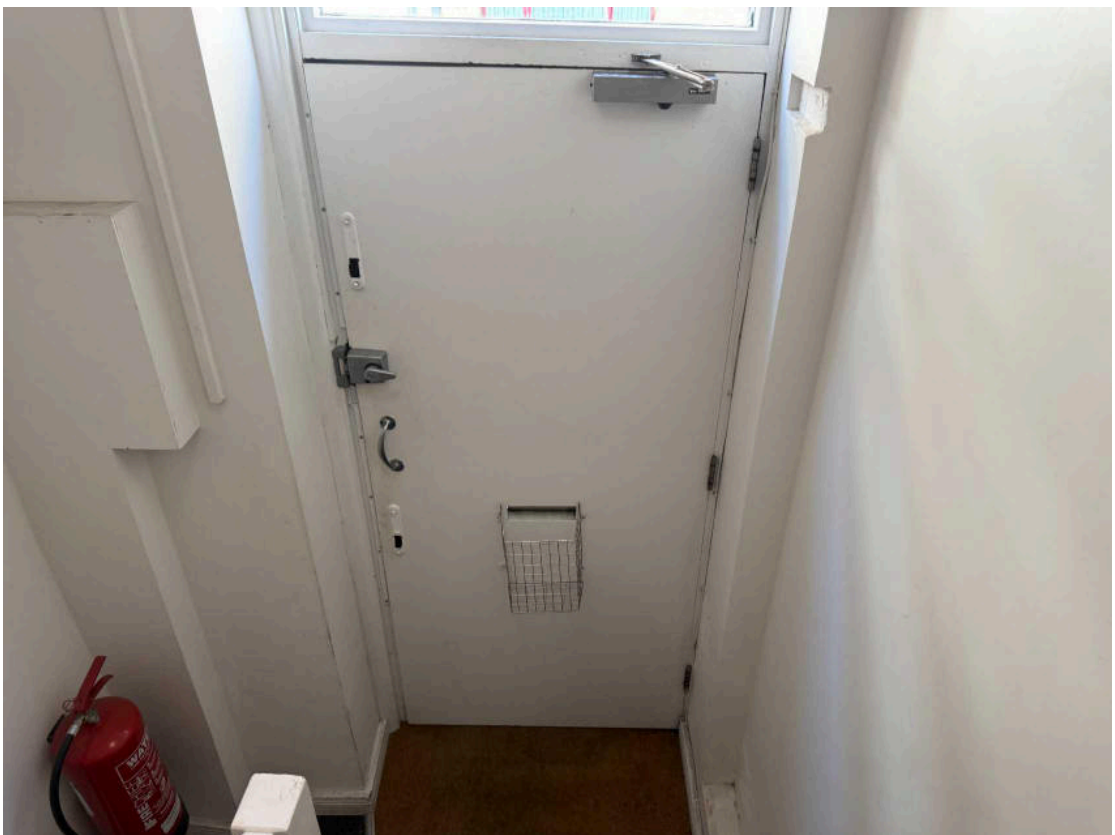
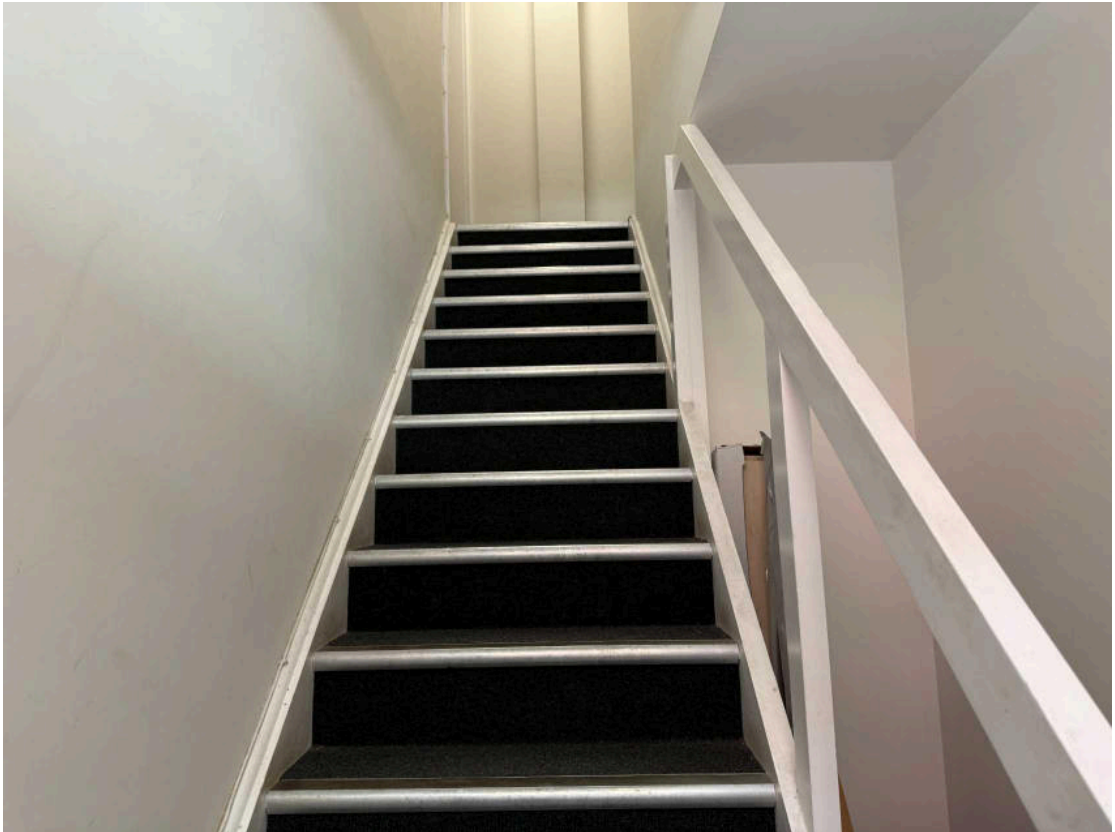
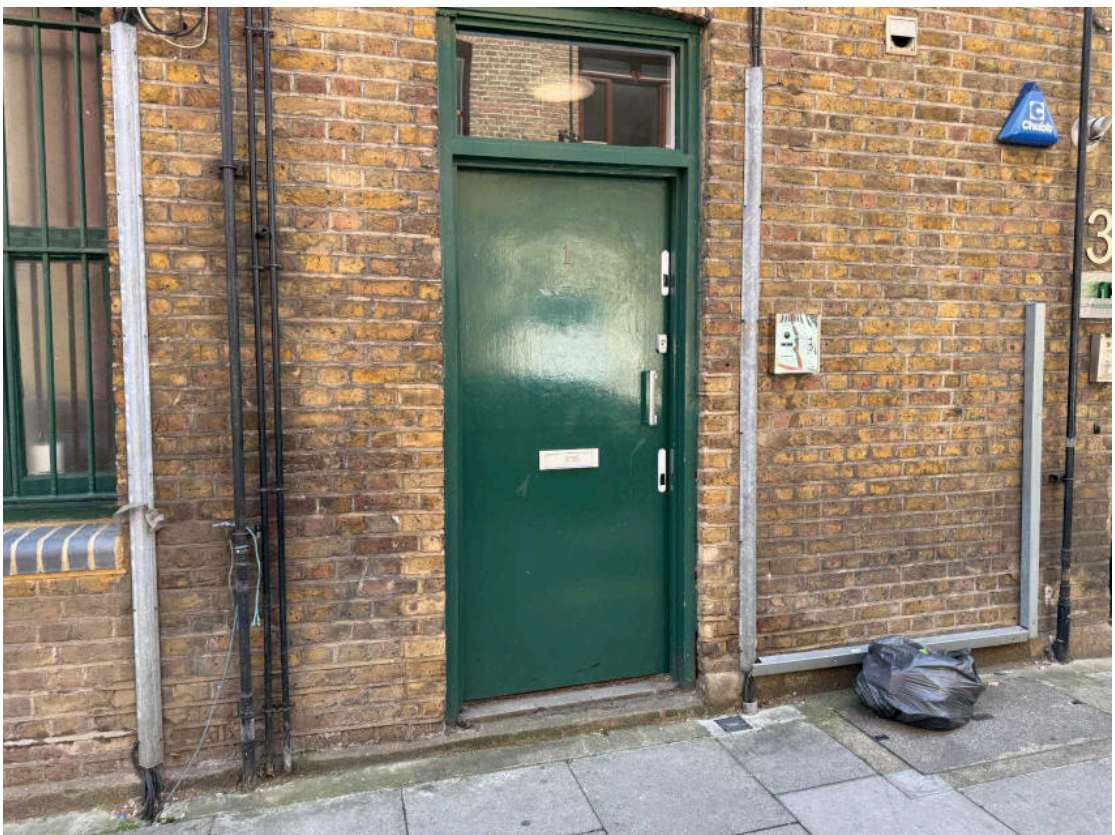
***Communal lobby***

Condition rating 1. No repair is required. The property should be maintained in a normal way.

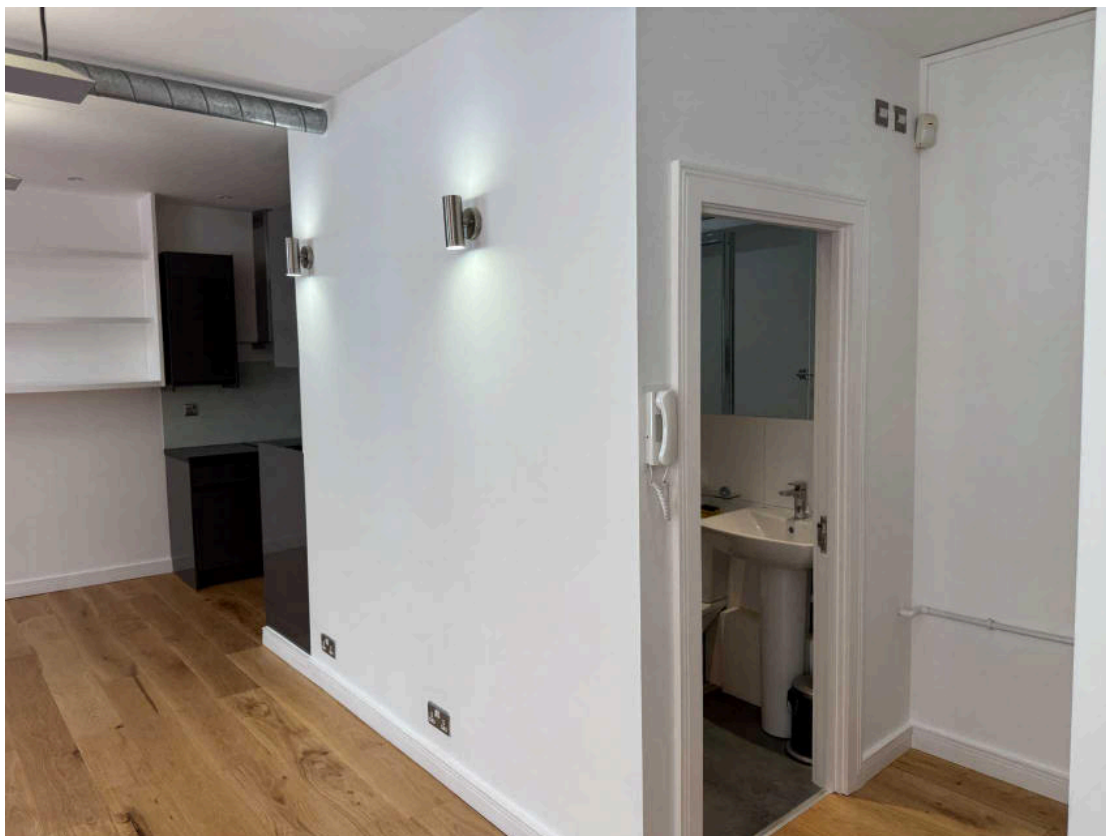
***Internal wall***

Condition rating 1. No repair is currently needed. The property must be maintained in a normal way.

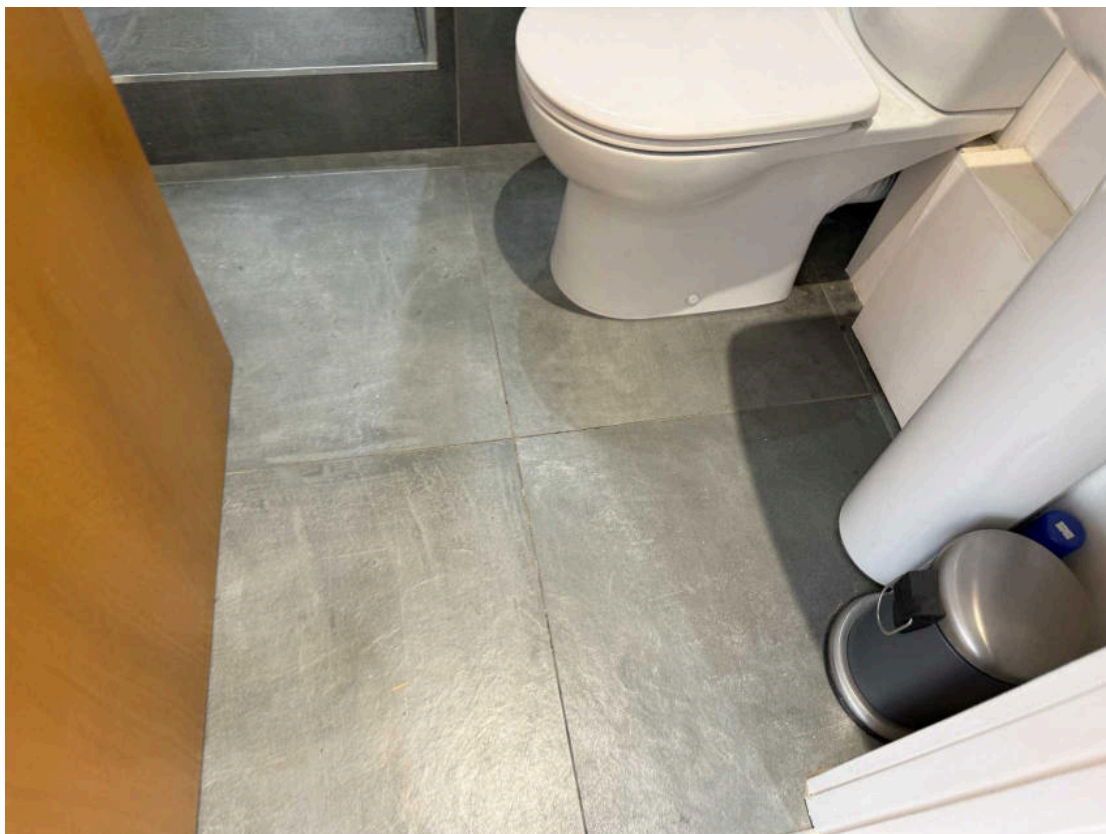
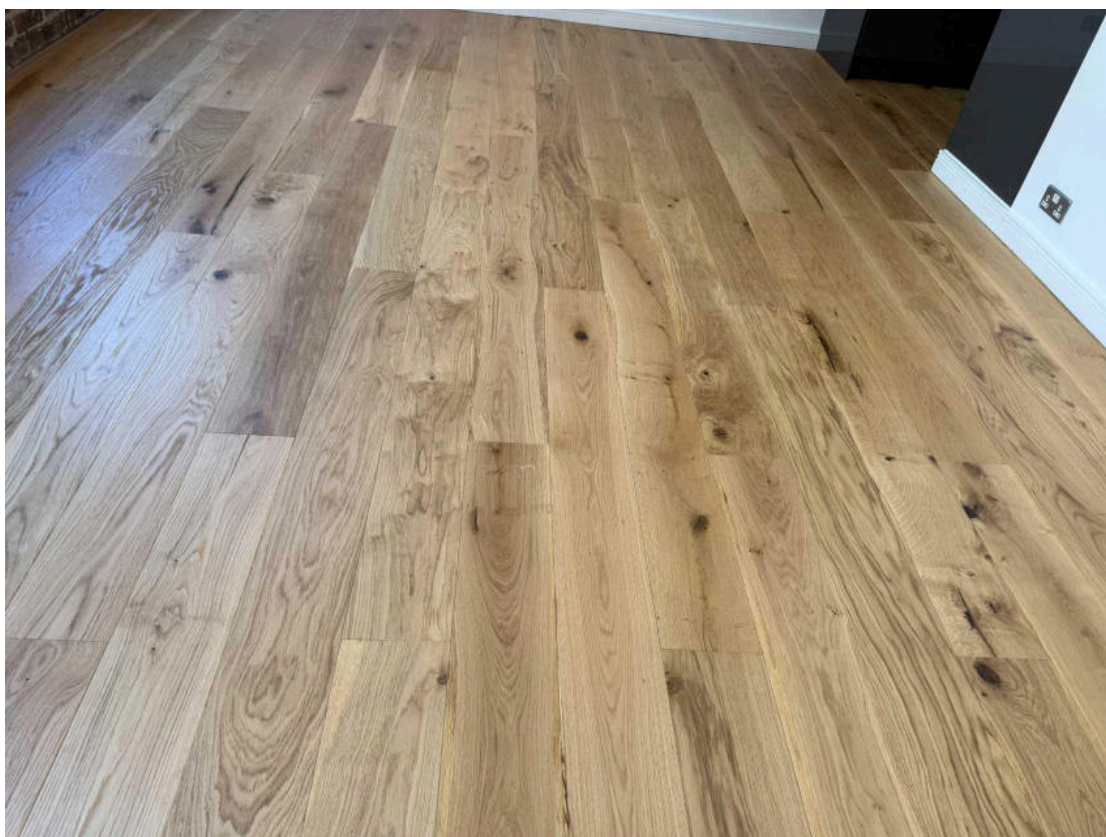
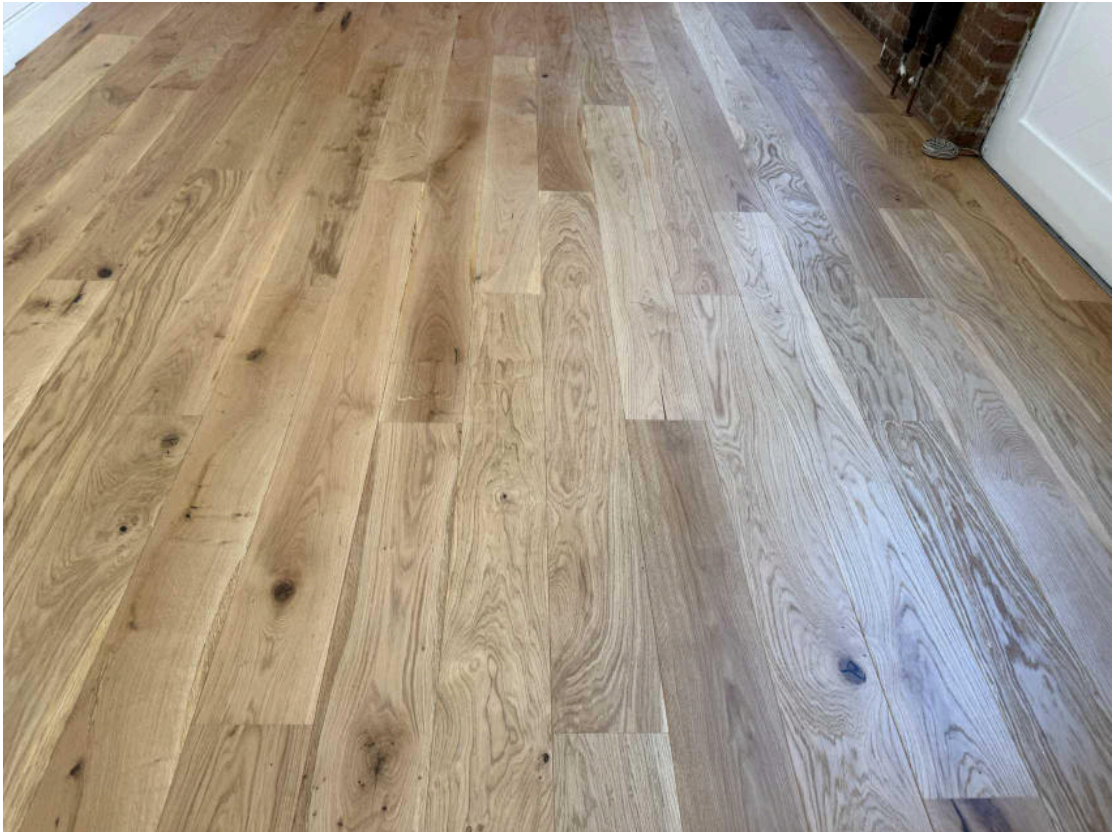
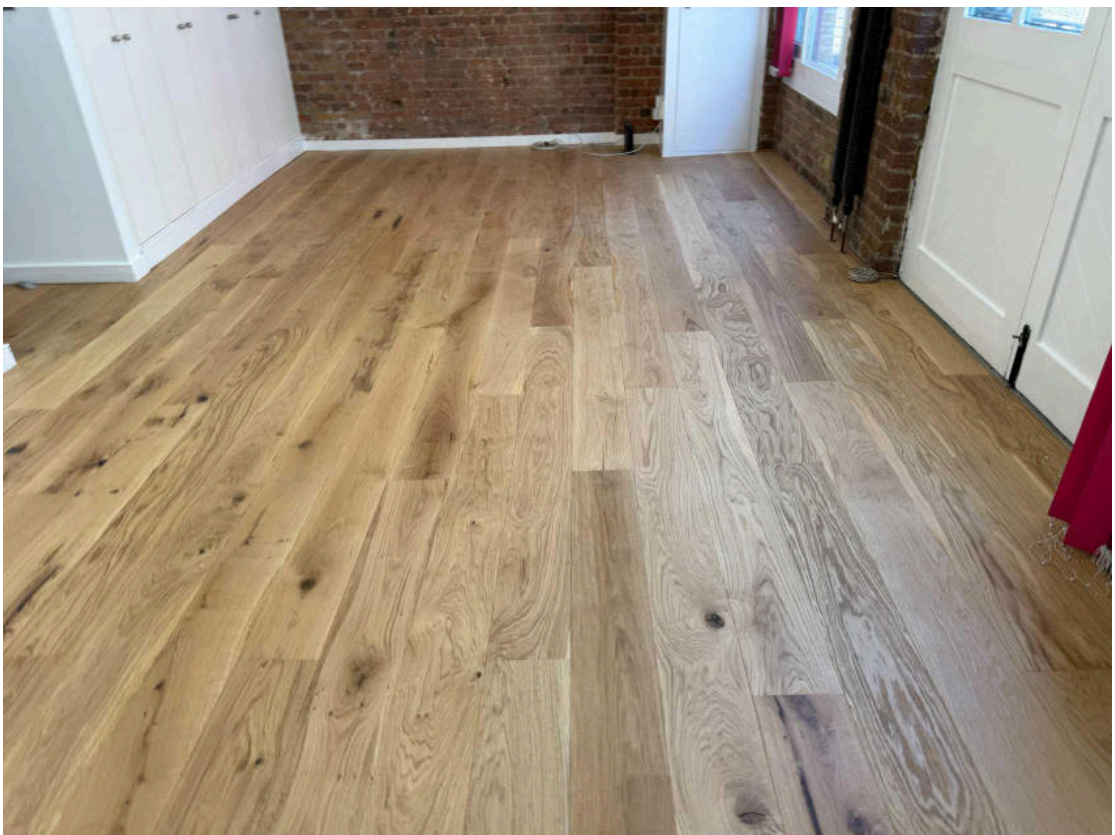
***Floor***

Condition rating 1. No repair is currently needed. The property must be maintained in a normal way.

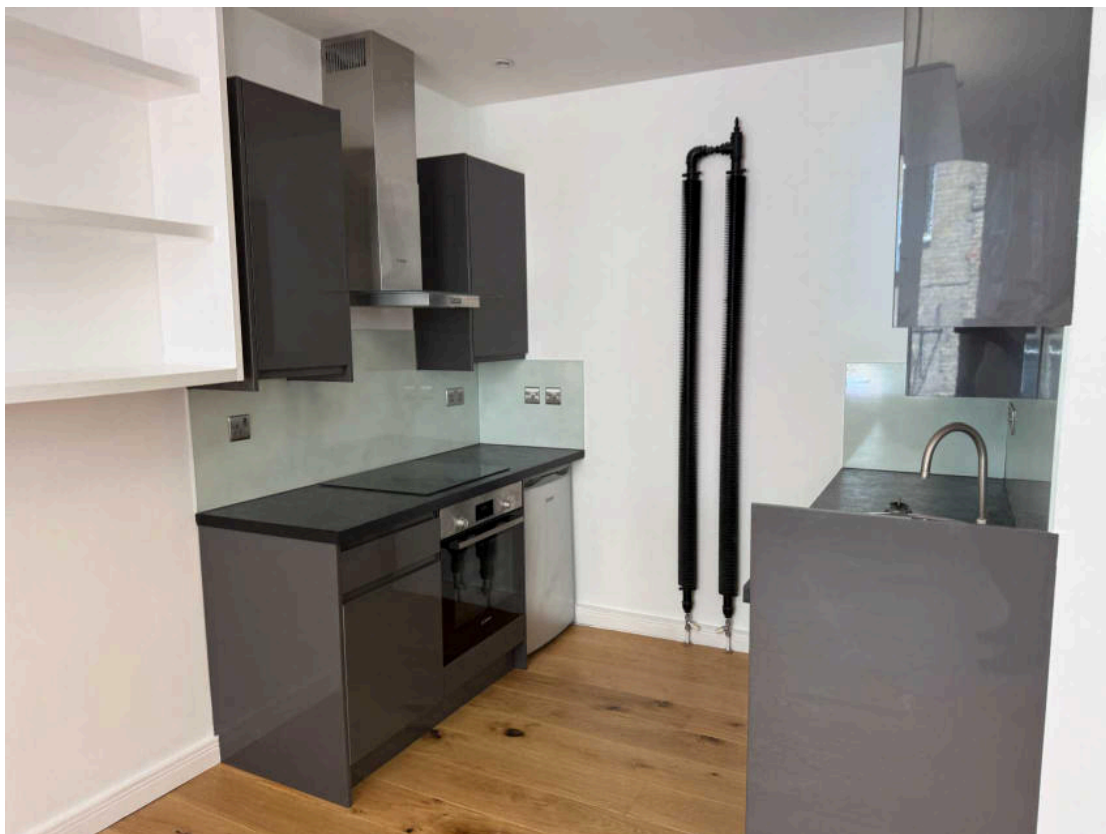
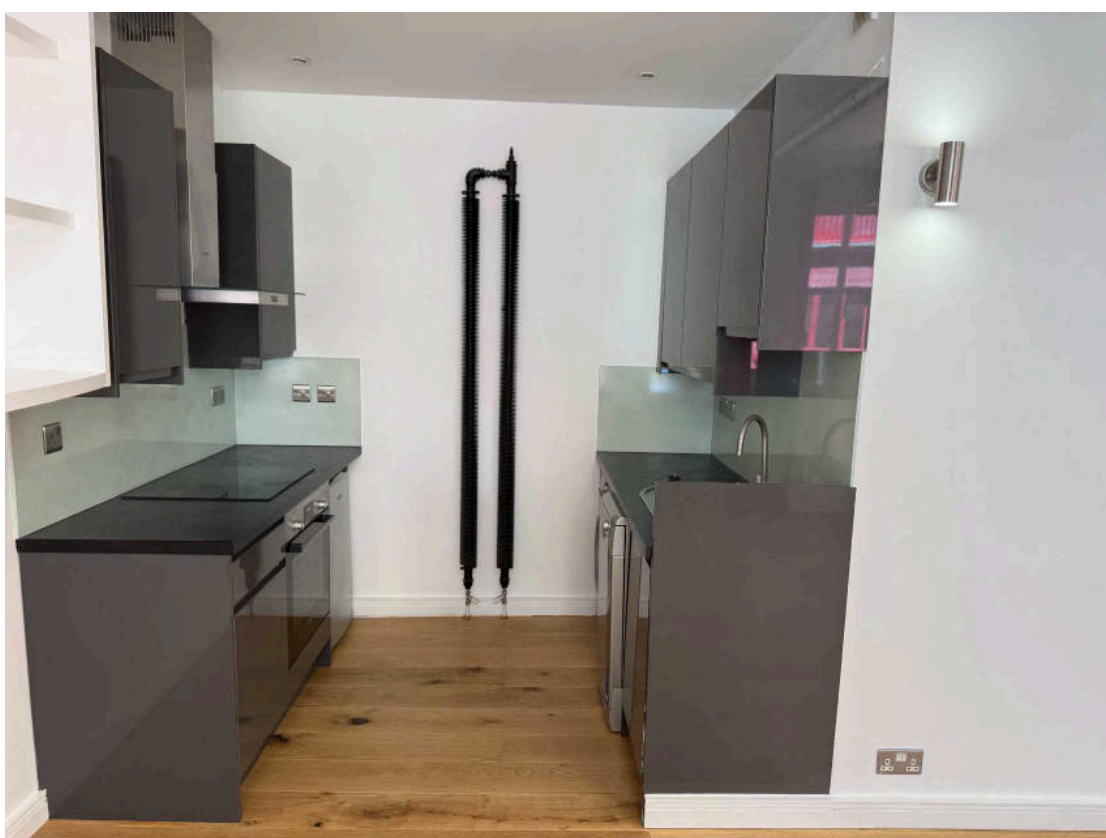
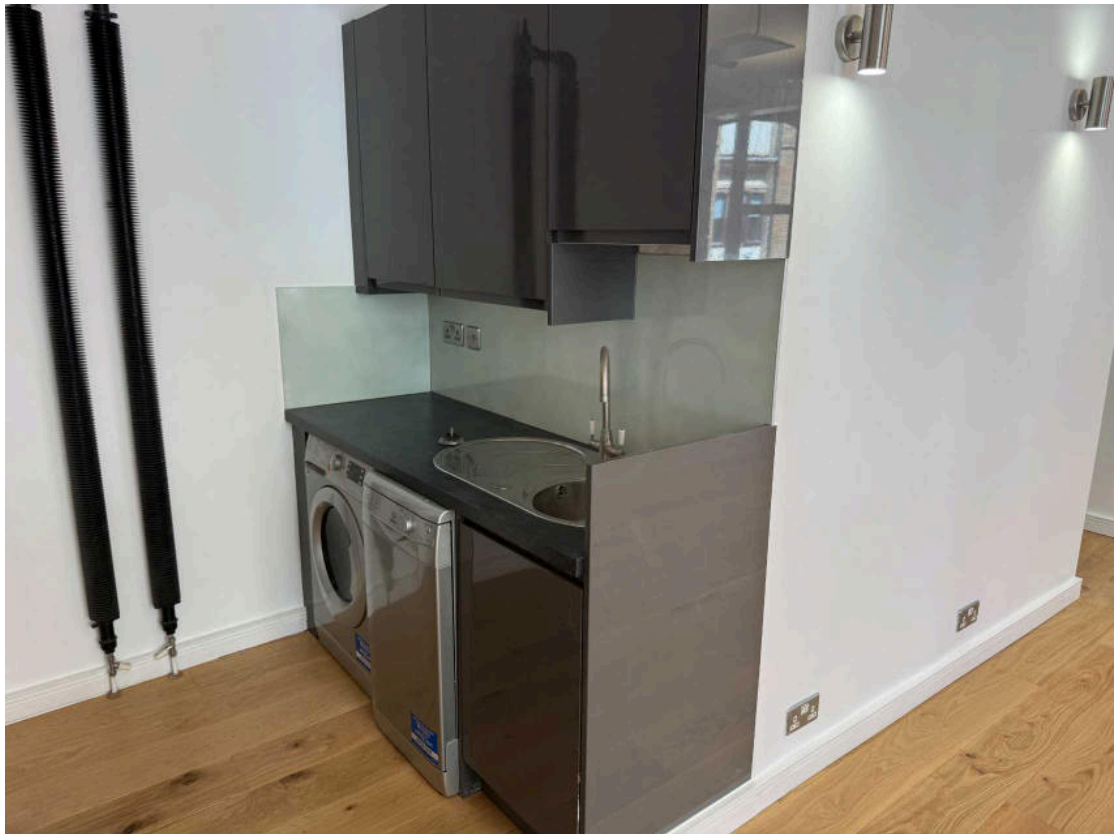
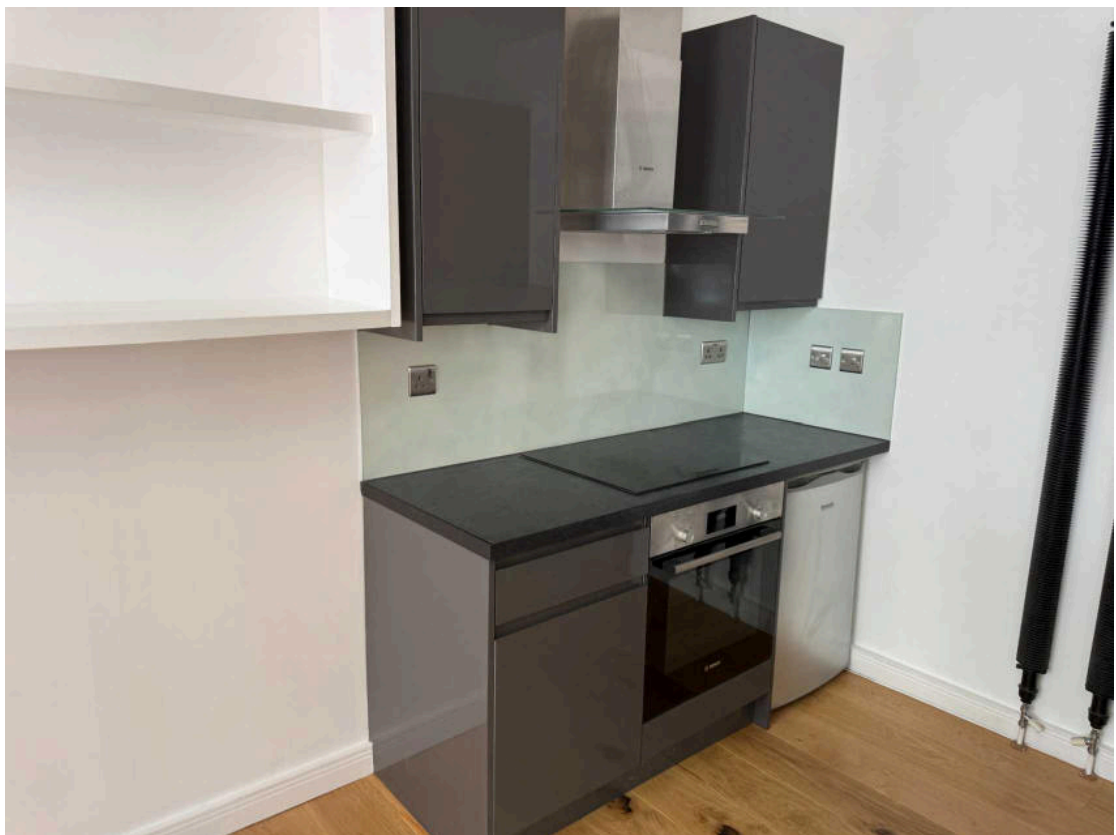
***Kitchen fittings***

Condition rating 1. No repair is currently needed. The property must be maintained in a normal way.

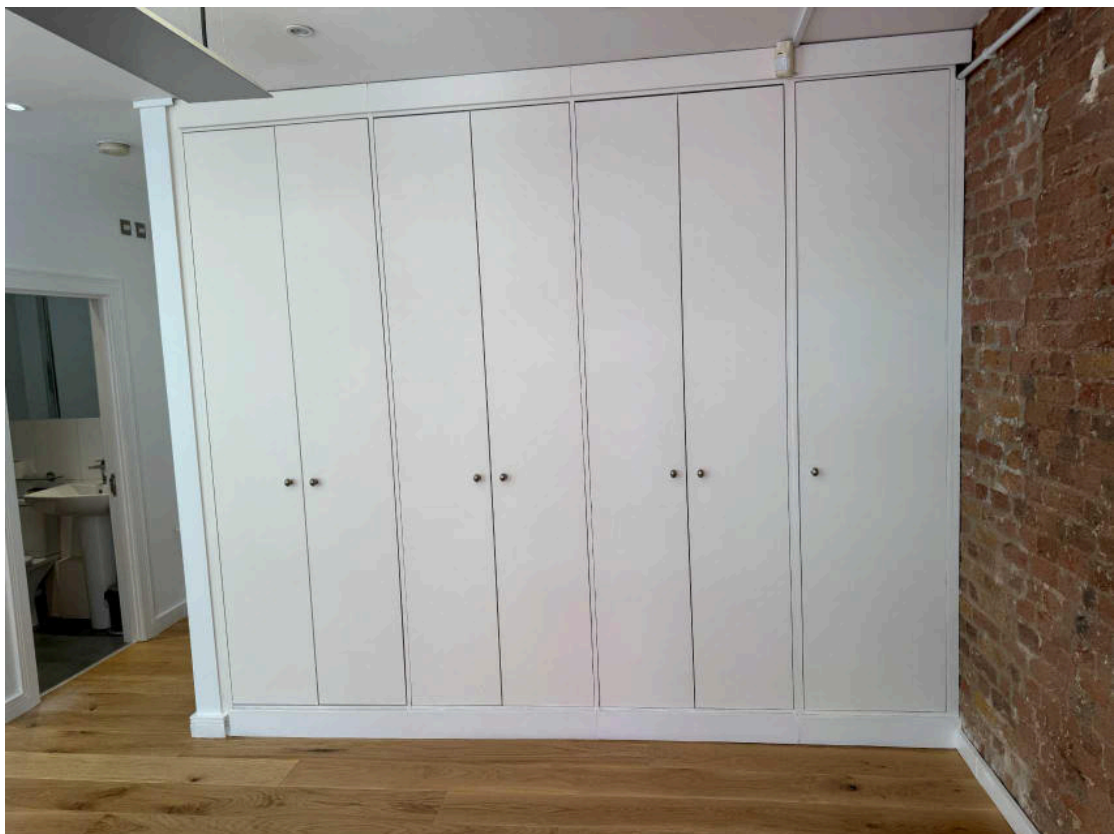
***Fitted cupboard***

Condition rating 1. No repair is currently needed. The property must be maintained in a normal way.
