LEVEL THREE

# Your survey report

██████ Luke Street, London, London, United  
Kingdom, EC2A ██████

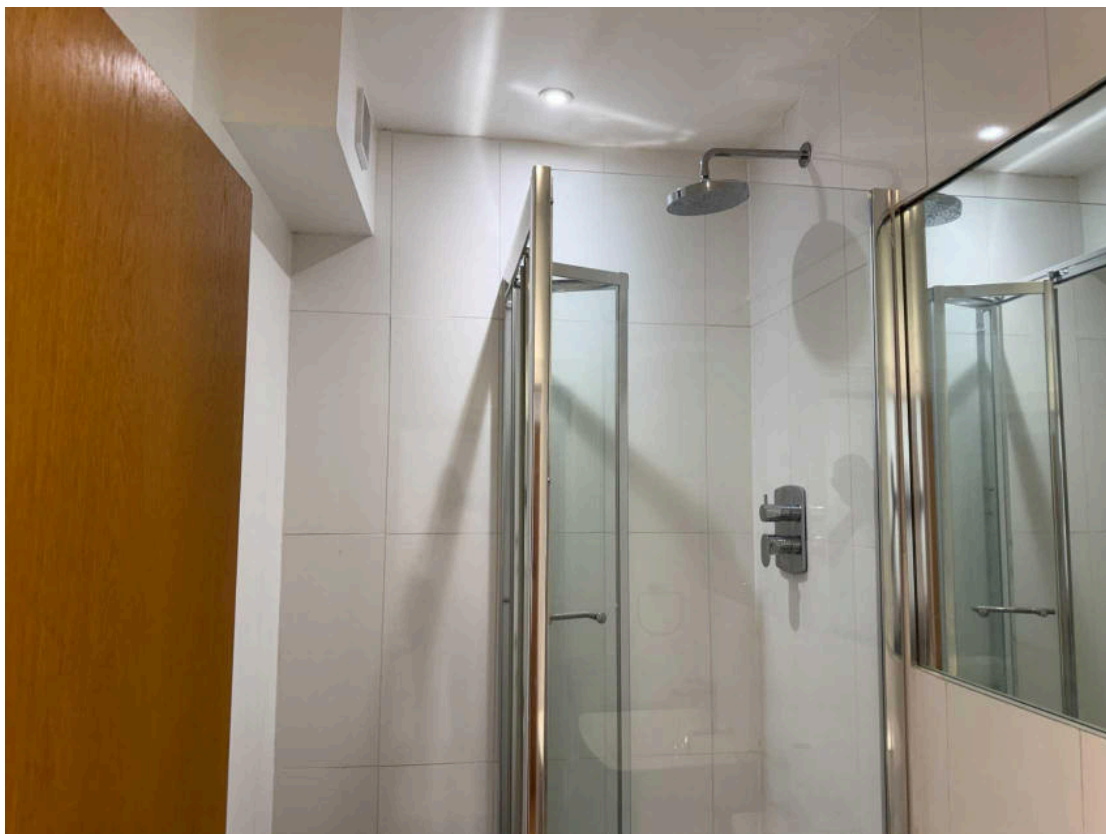
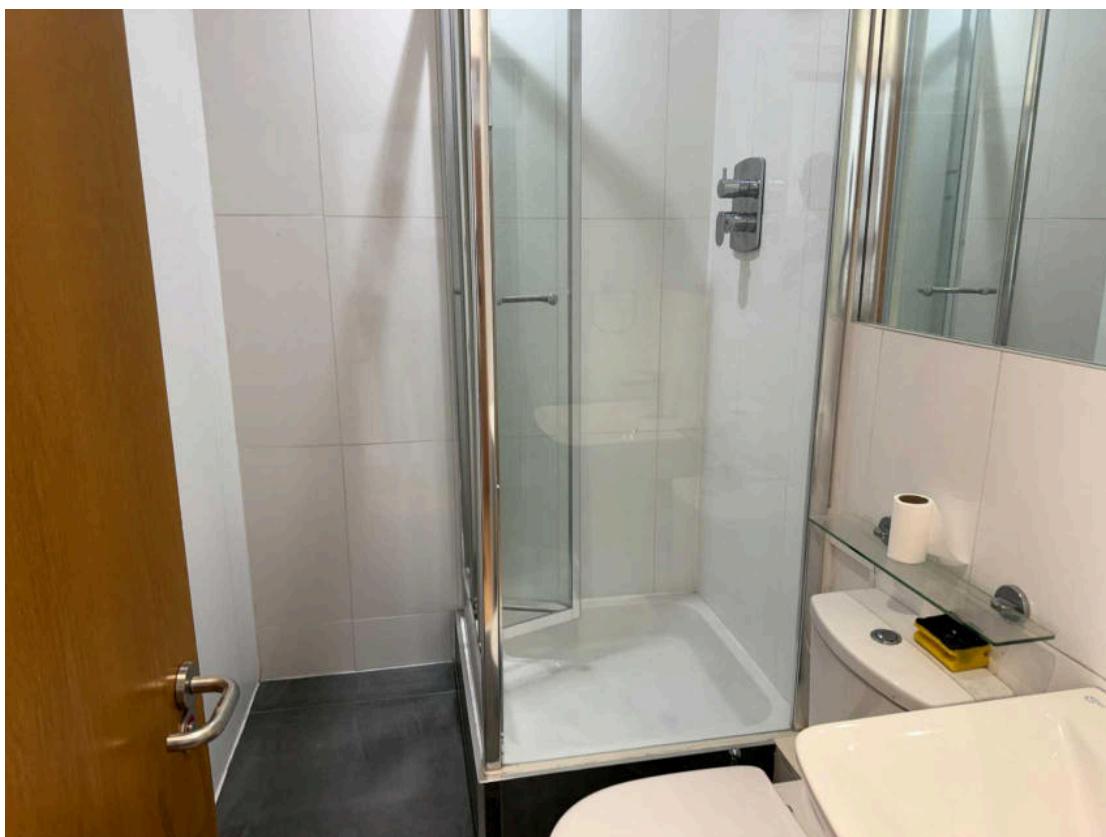
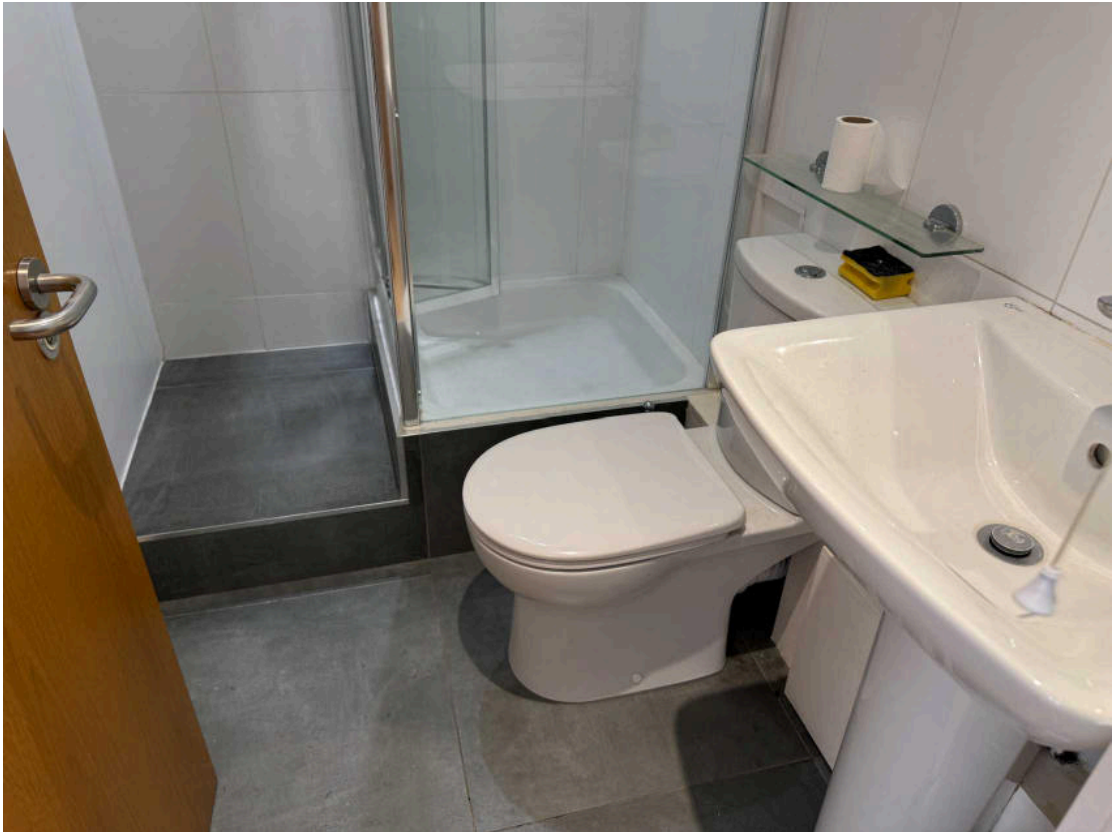
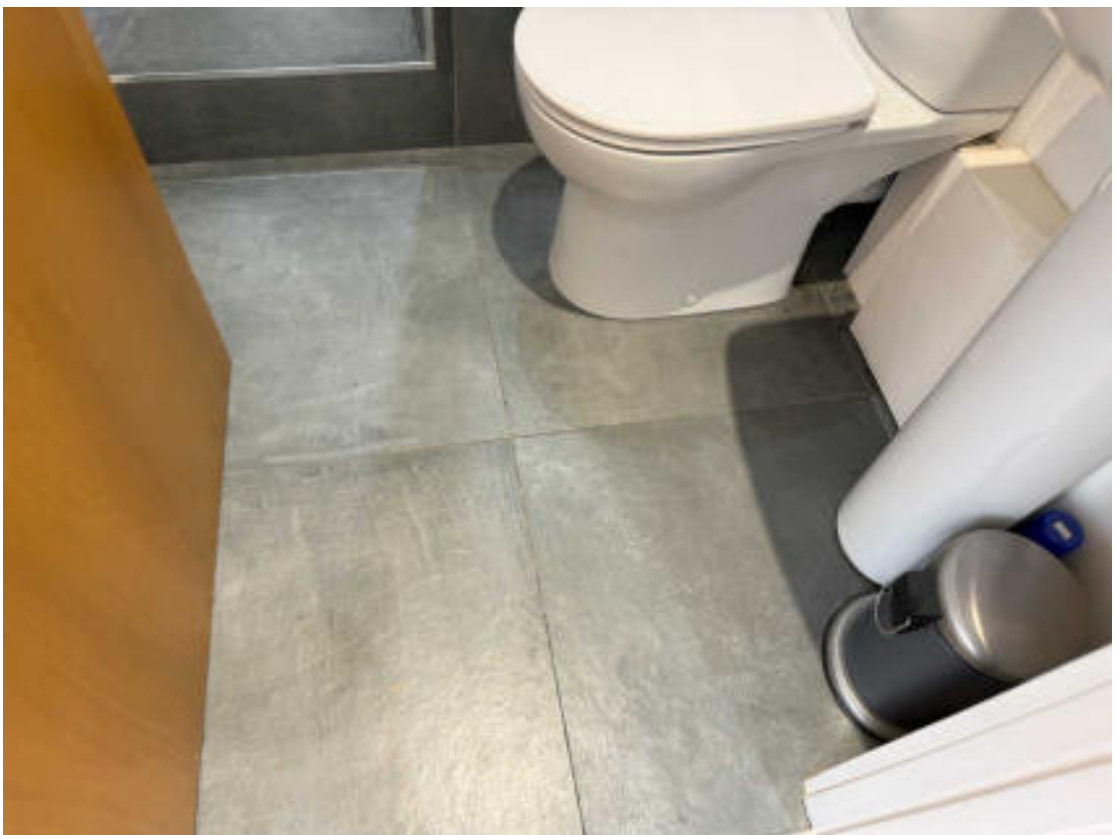
***Sanitary fittings***

Condition rating 1. No repair is currently needed. The property must be maintained in a normal way.

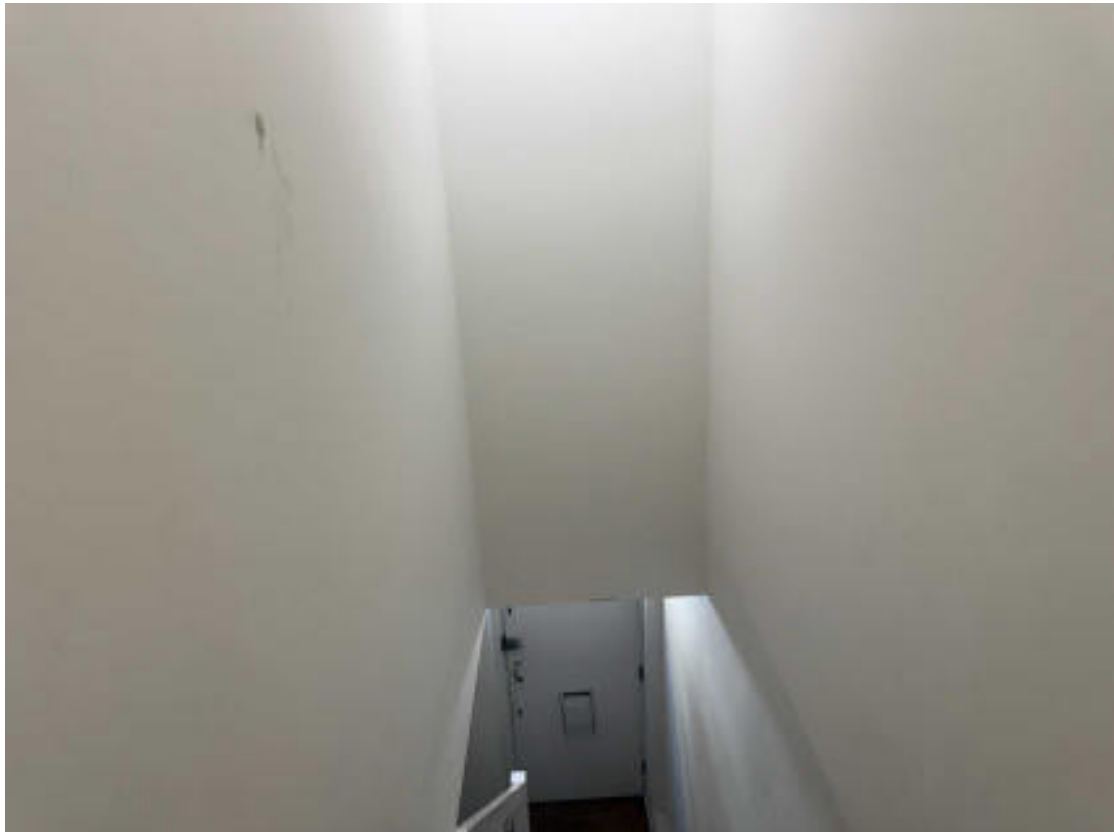
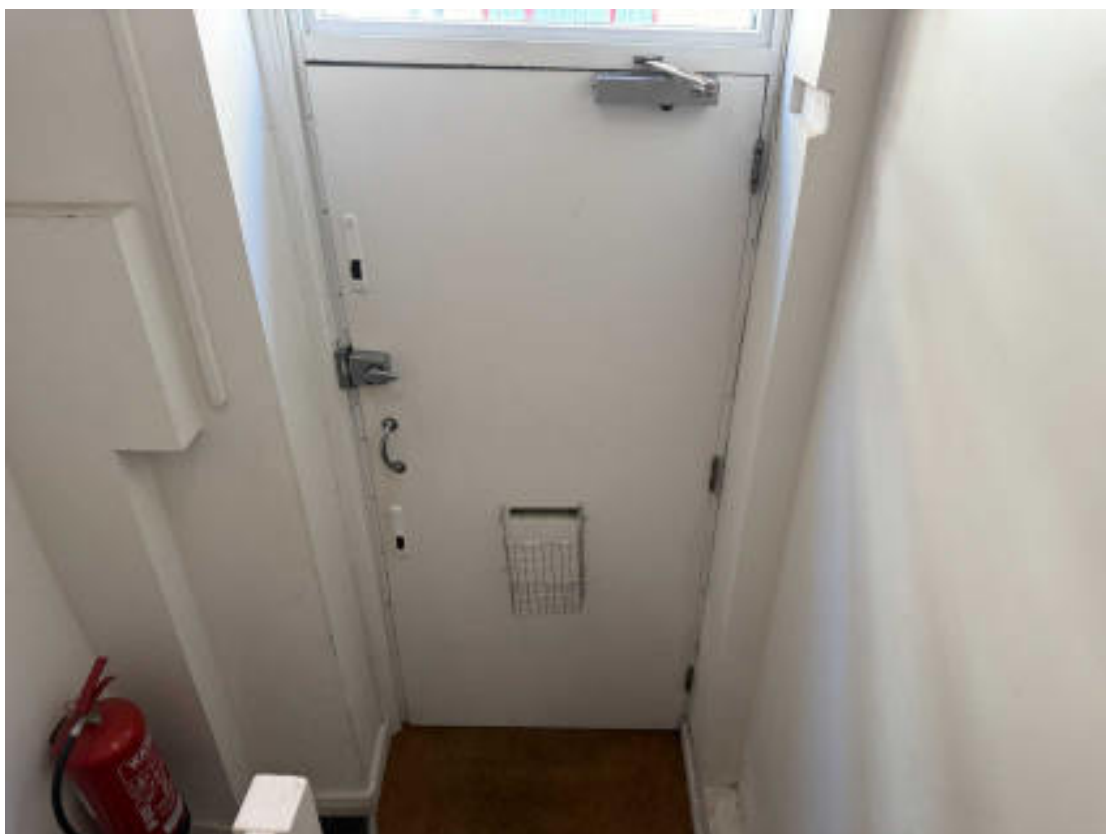
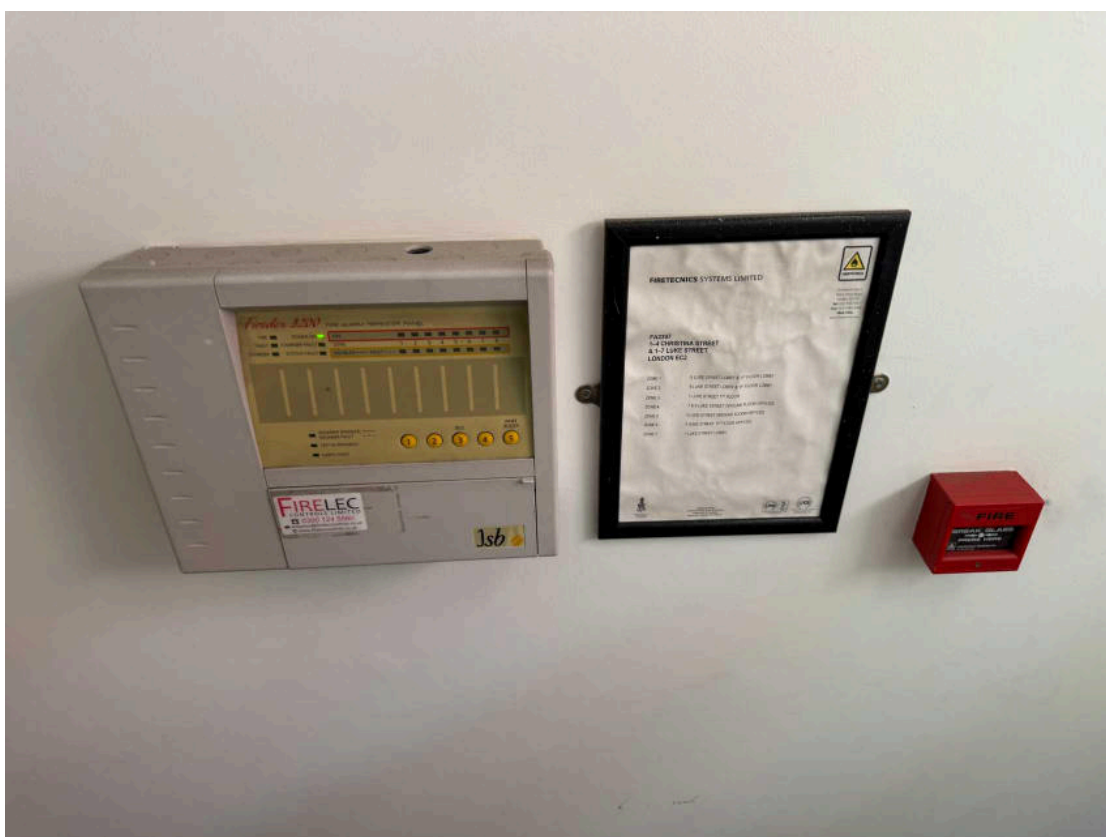
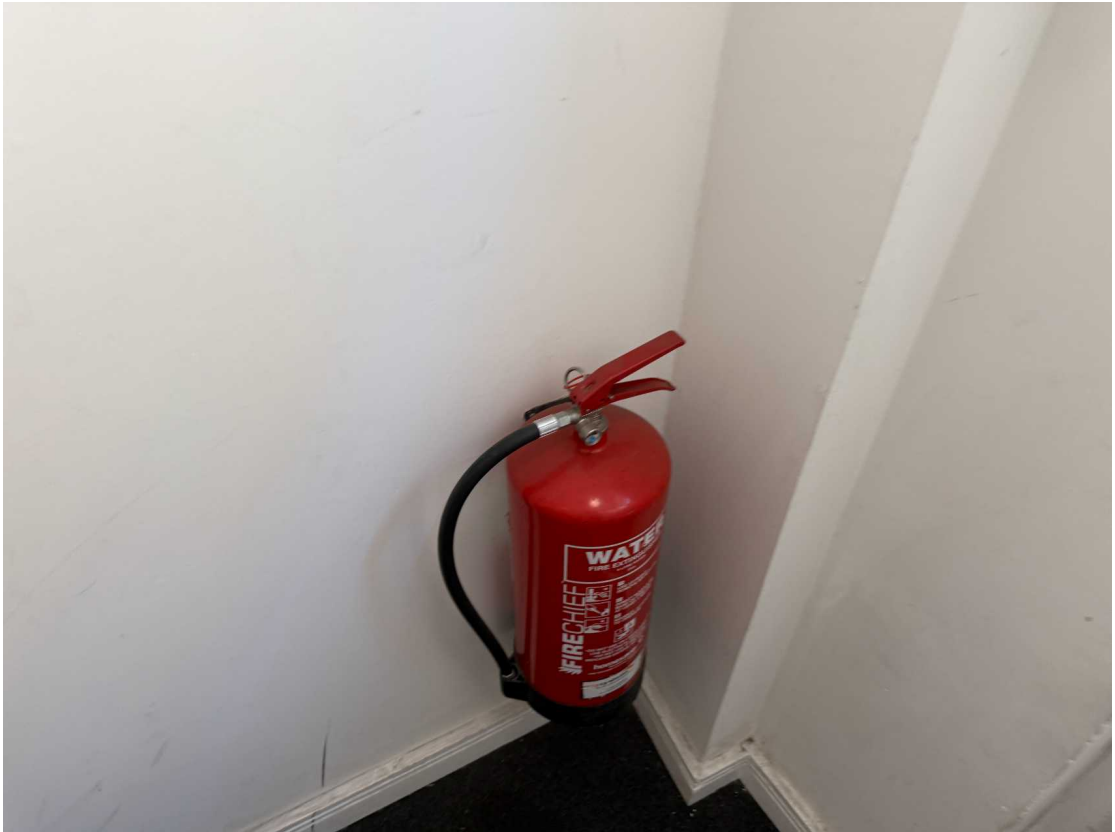
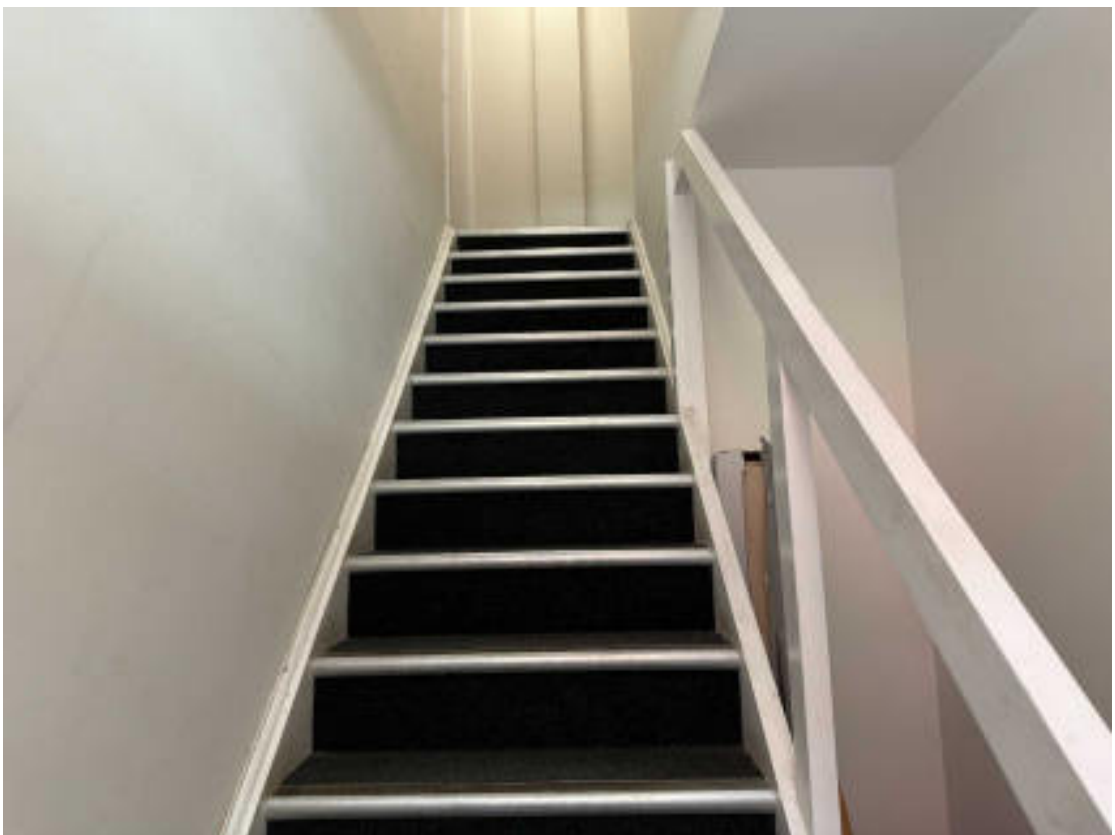
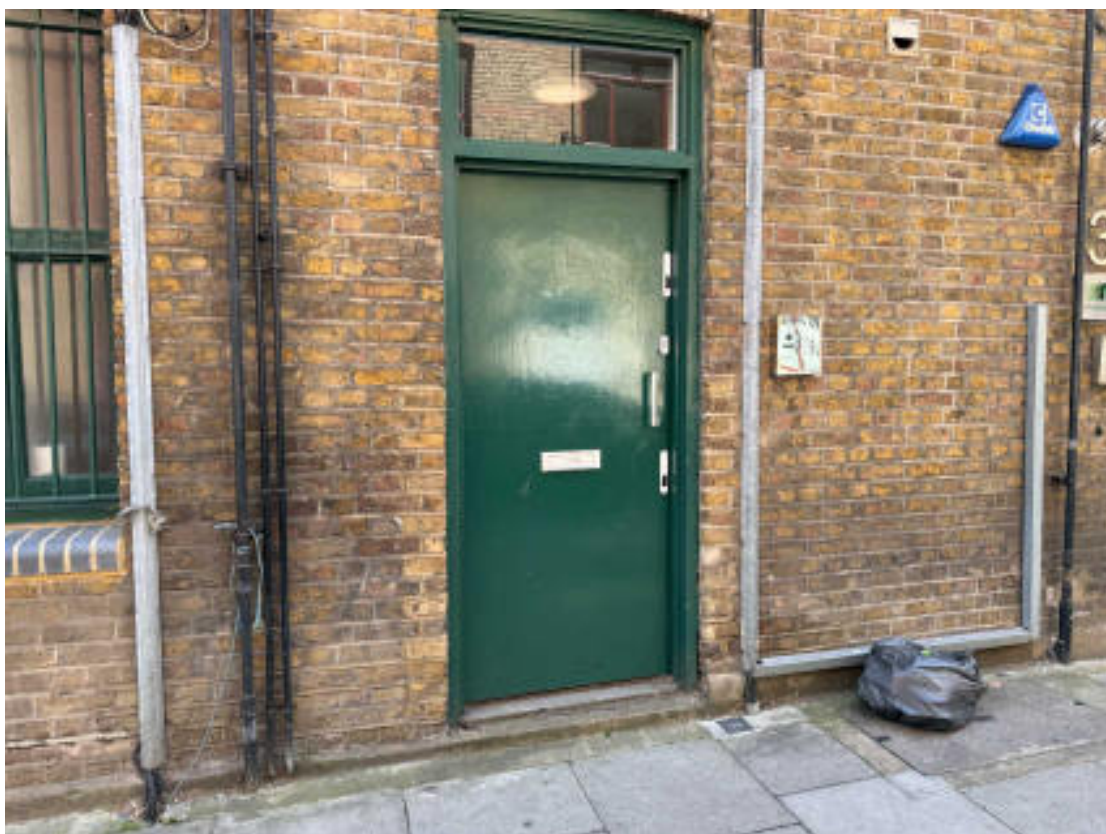
***Communal lobby***

The communal area of the building, to the front, is a communal entrance door, timber floor, lobby, enclosures, passenger lift, and communal staircase and landing, with usual wear and tear discolouration to decorative finish and flooring.

Condition rating 1. No repairs are required, and the property must be maintained in the normal way.

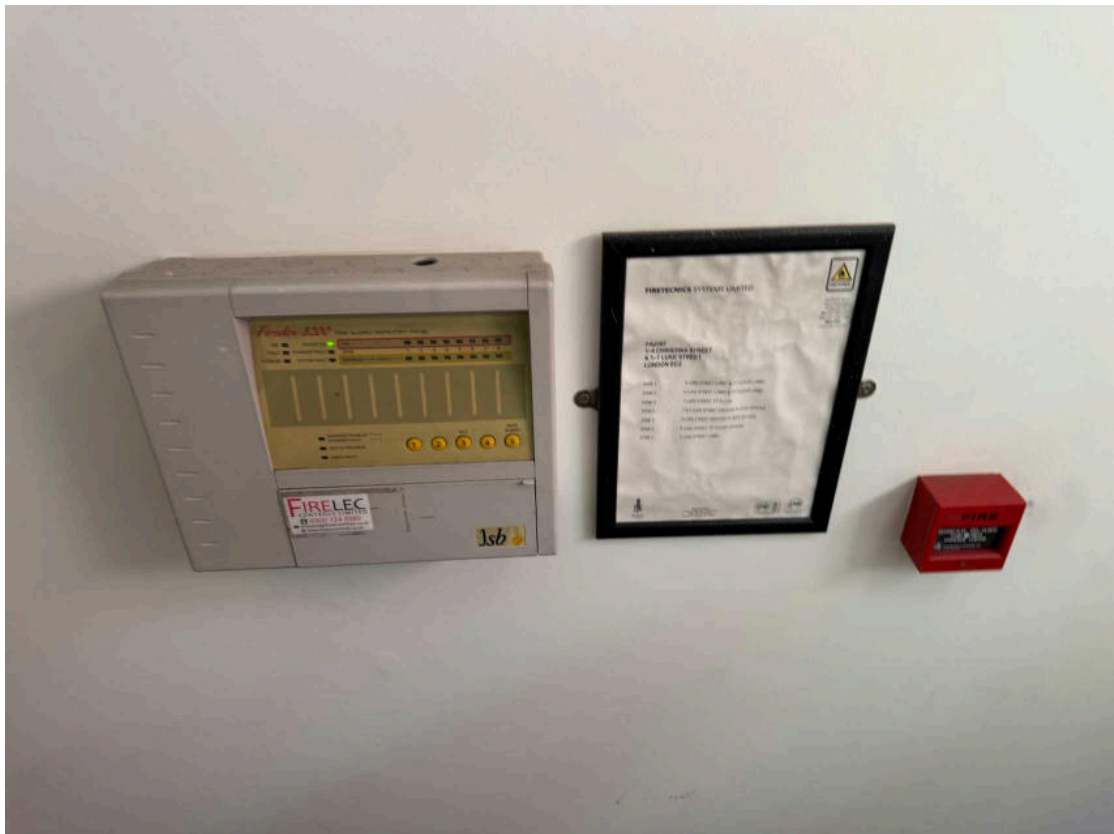
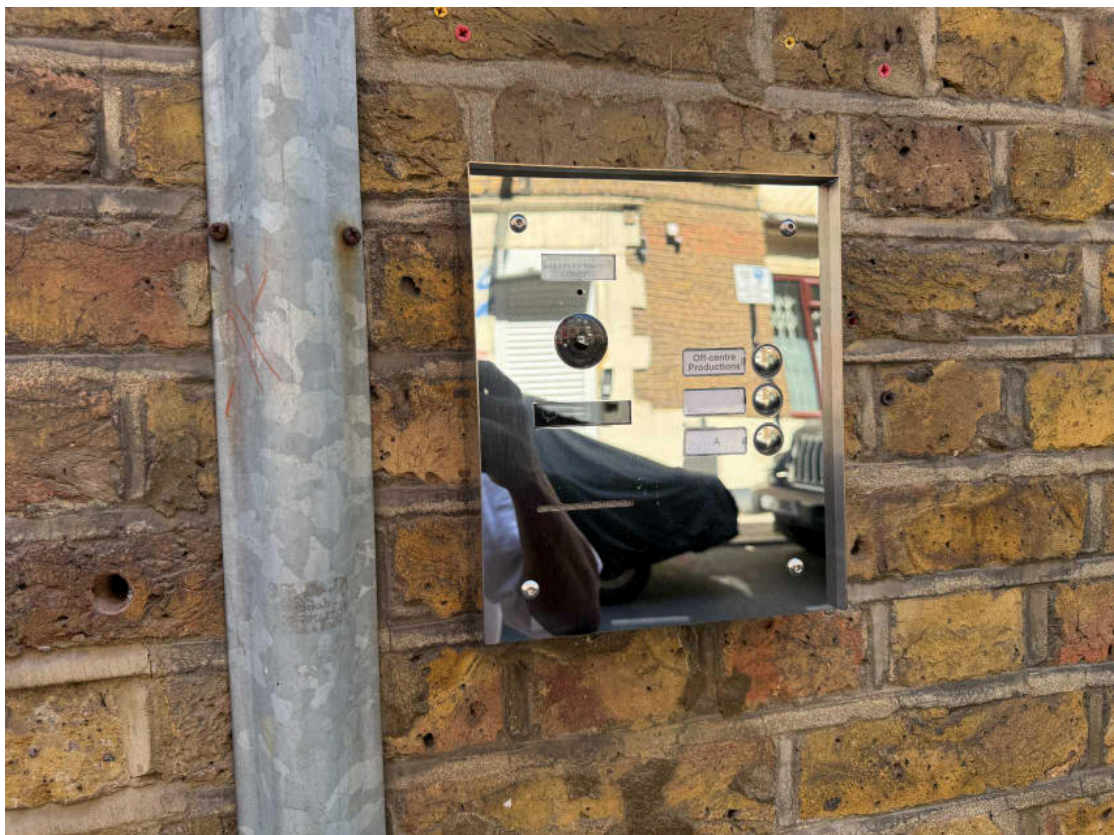
***Fire and smoke detection system***

Condition rating 1. No repairs are required, and the property must be maintained in a normal way.

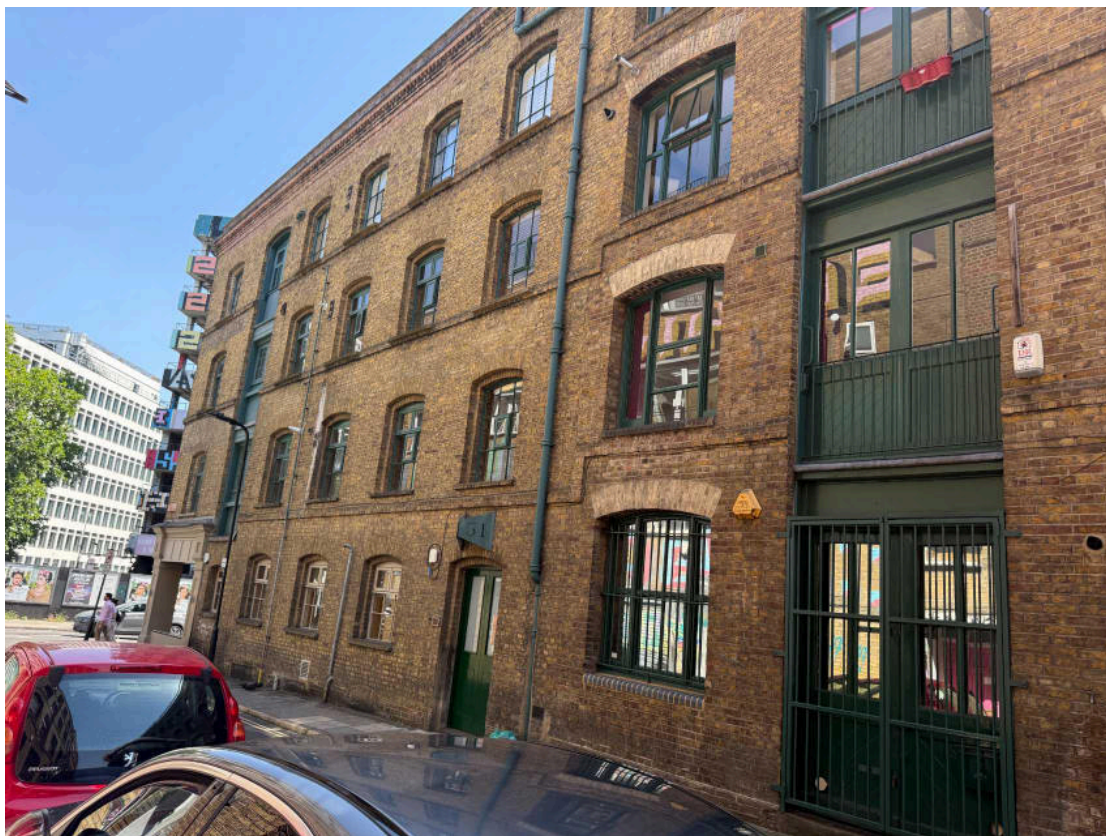
*The building*

Condition rating 1: No repair required. The property must be maintained in a normal way.
